Preliminary Geotechnical Report

Cherry Channel Drainage Project

Beaumont, California

September 23, 2024 | Project No. 212774002

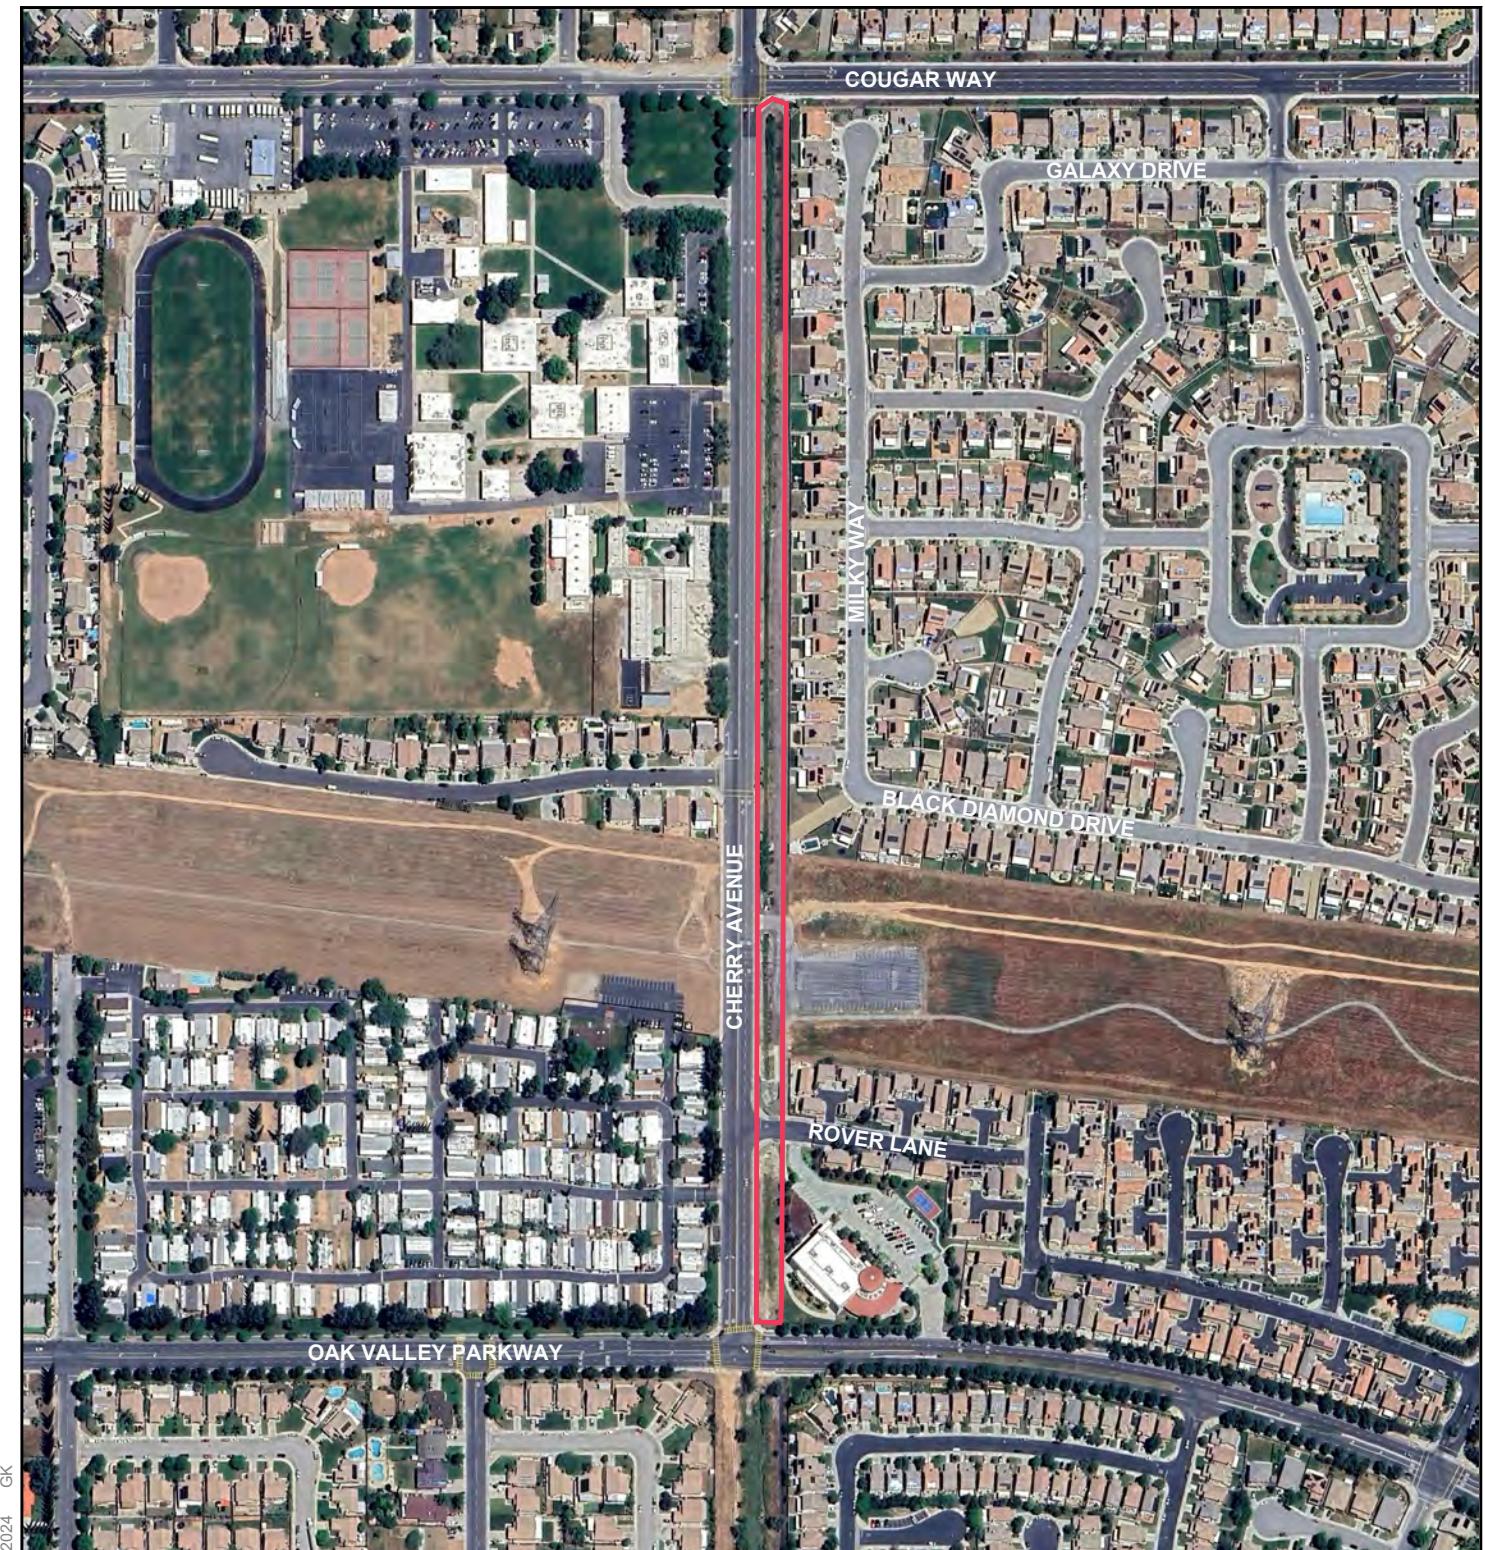
FIGURE 2

The proposed Cherry Channel Drainage Project is located along the eastern side of Cherry Avenue between Cougar Way and Oak Valley Parkway in Beaumont, California (Figure 2). The project area is approximately 2,500 feet long and is bounded by Cherry Avenue to the west, Cougar Way to the north, Oak Valley Parkway to the south, and asphalt concrete paved pedestrian walkway, single-family residential developments, and a community center to the east. A utility easement with high-voltage transformers crosses near the center of the Channel alignment. The existing Cherry Channel is a trapezoidal unlined earthen drainage Channel approximately 38 to 60 feet in width and 8 to 12 feet in depth. The Channel walls have a slope gradient of approximately 2:1 (horizontal to vertical) (Exp., 2024). The Channel is lined with a geo-mat along the side slopes and Channel bottom. Based on our site observations, the existing geo-mat is in

poor condition with exposed, missing, or torn sections. The Channel contains localized areas of riprap and sparse to high vegetation along its slopes and Channel bottom. In addition, the Channel slopes have been eroded from urban run-off and contain holes from burrowing animals. Rover Lane crosses over the Channel approximately 400 feet north of Oak Valley Parkway and the entrance to the Albert A. Chatigny Senior Community Recreation Center's overflow parking lot crosses over the Channel approximately 800 feet north of Oak Valley Parkway. Additional existing improvements along the Channel include concrete drain outlets along the Channel, irrigation systems adjacent to and on the Channel slopes, and landscaping adjacent to the Channel.

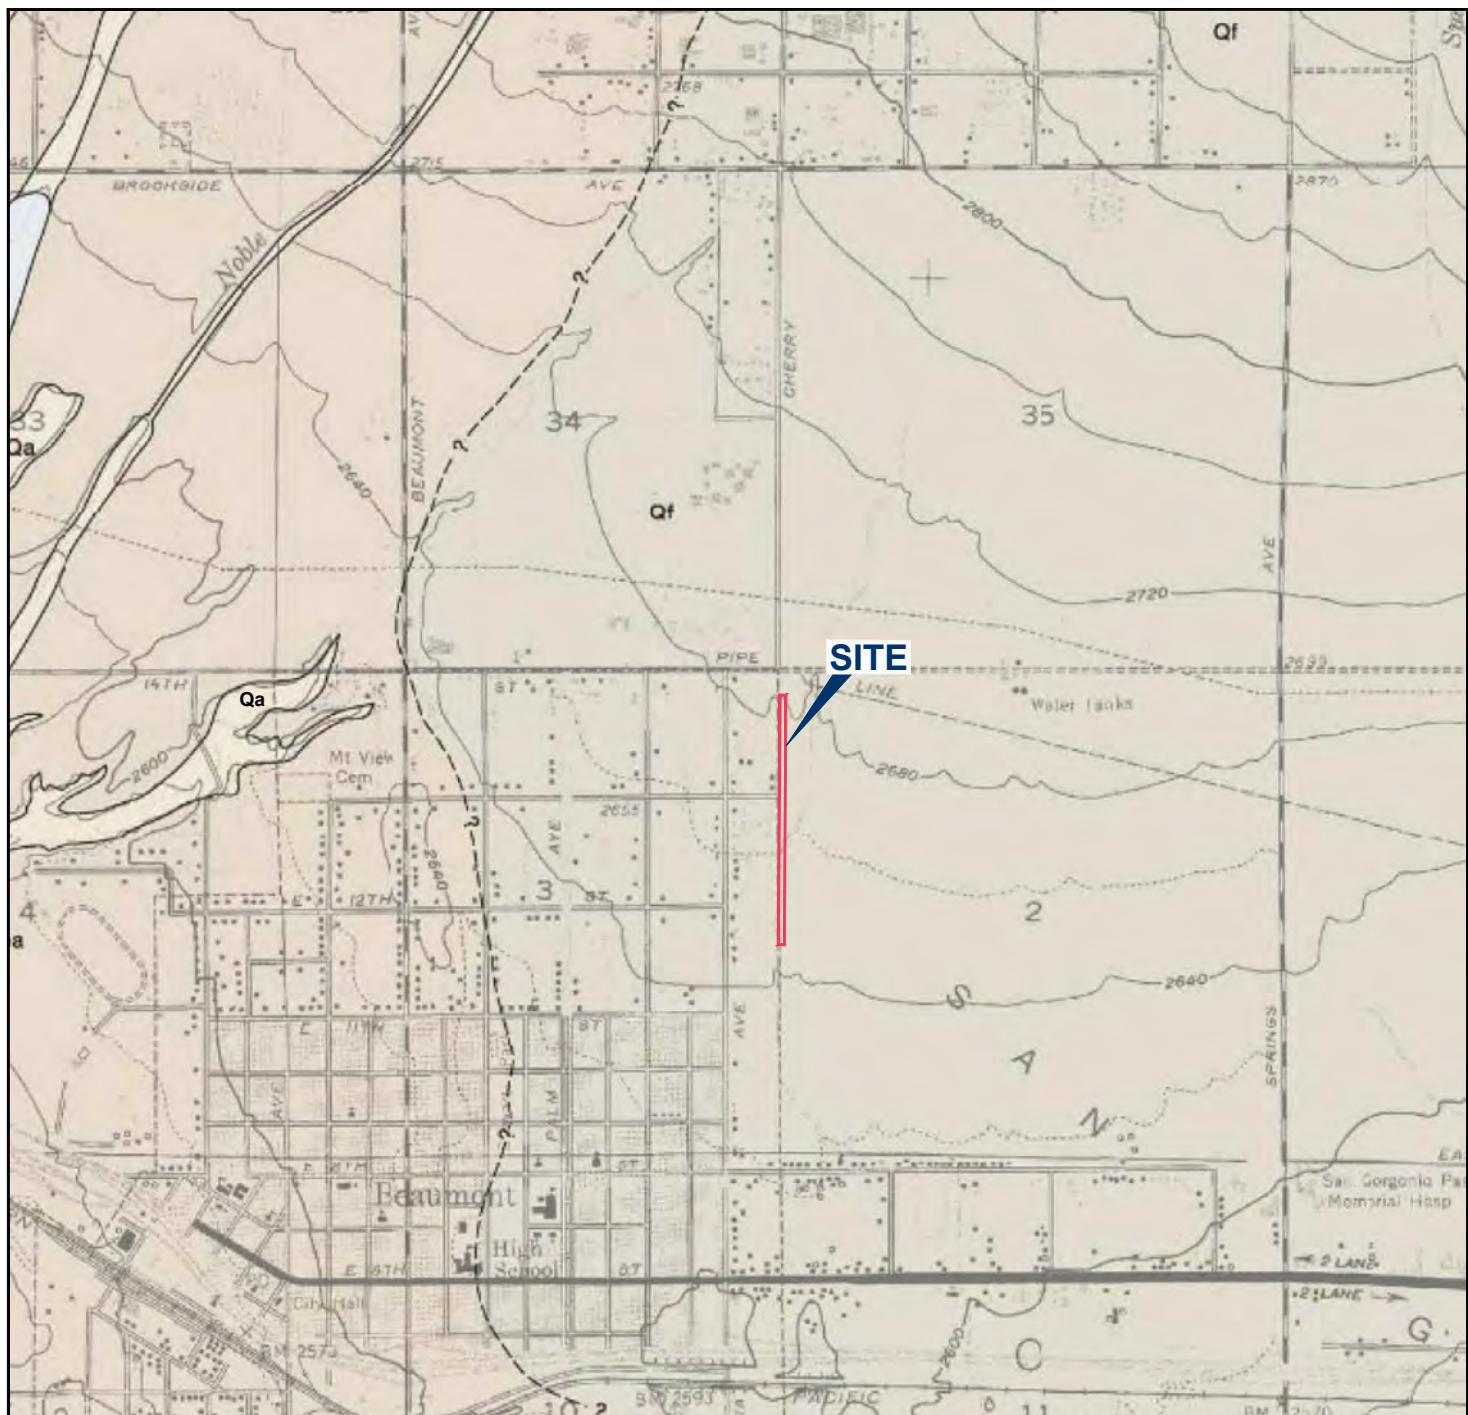
FIGURE 3

Based on our review, the site is mapped as being underlain by Holocene to late Pleistocene-age alluvial fan deposits consisting of sand and gravel of plutonic and gneissic detritus derived from the San Bernardino Mountains to the north (Dibblee, 2003) as shown on Figure 3.
