Appendix C3 -DBESP Report

BEAUMONT SUMMIT STATION PROJECT DBESP REPORT

Riverside County, California

February 1, 2022

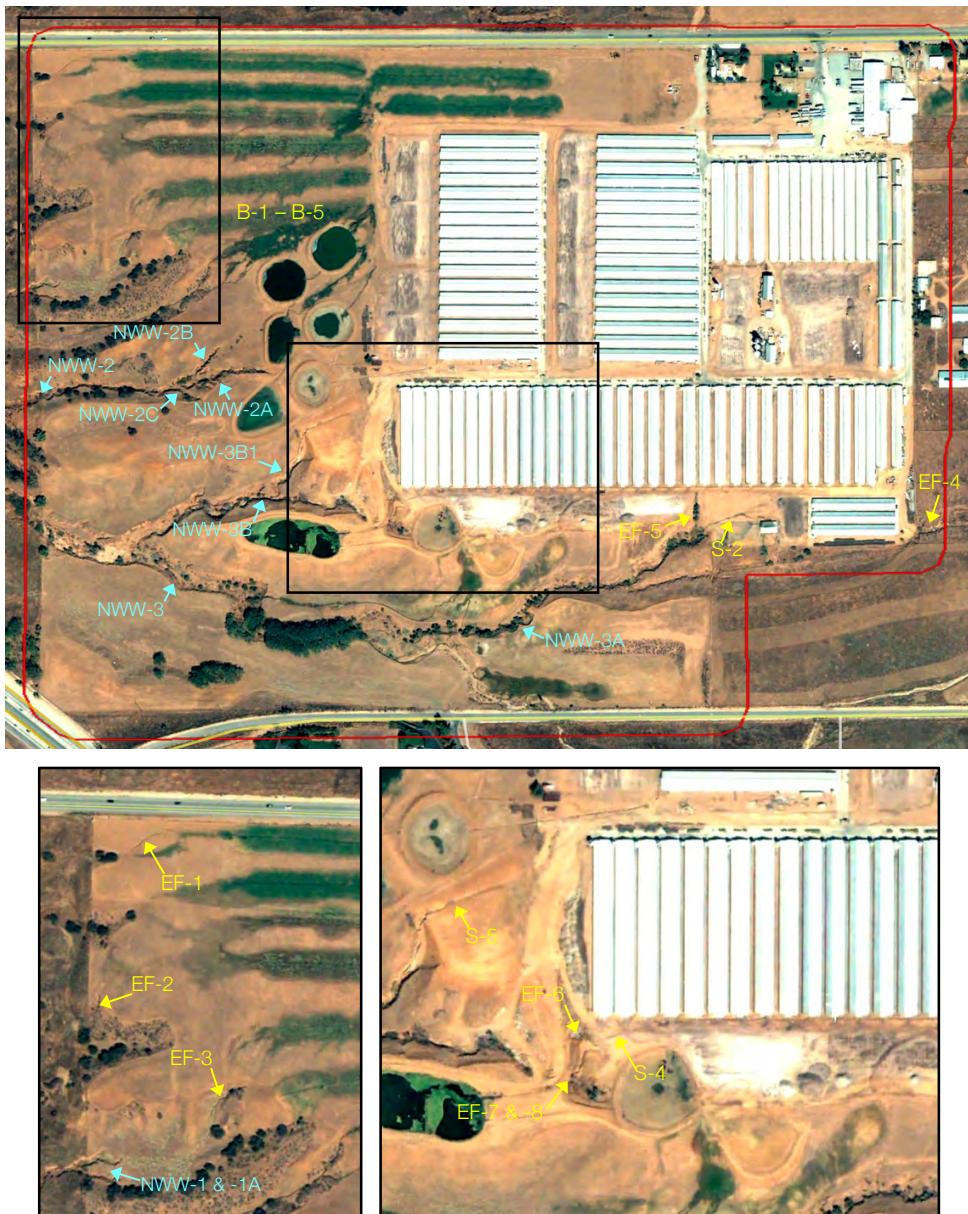
October 2003 – Farming operations within the review area continue to expand between September 1996 and October 2003 with the construction of more poultry sheds in the center of the review area. Additionally, more ponding basins (i.e., B-3 through B-5 and various other unnamed basins) were developed during this time. Remains of these developments and site modifications exist to this day. B-1 and B-2 are still present; however, no longer appear to drain runoff into NWW-2 and NWW-2B. Furthermore, NWW-3B no longer appears to receive flows from the unnamed basin in the center of the review area. NWW-1, NWW-1A, NWW-2, NWW-2B, NWW-2C, NWW-3, and NWW-3A are visible on the aerial in their current locations. The expanding farming operations continue to contribute to further reductions of NWW-3B and NWW-3B1. By October 2003, NWW-3B and NWW-3B1 were reduced to their current extents. NWW-2A is primarily only visible near its convergence with NWW-2.

EF-1 through EF-3 are visible and appear to receive runoff from a new irrigation system within the review area. EF-4 is evident, and EF-5 still appears to receive runoff from the poultry sheds. S-1 is further indistinguishable and appears to likely contain the same characteristics as those observed present-day (i.e., no break in slope or a defined bed and bank between the swale and adjacent uplands). S-2 has reemerged and appears to receive runoff from farming operation buildings. The expansion of the poultry sheds appears to result in S-4 and EF-6 becoming slightly apparent and S-5, EF-7, and EF-8 being visible in their current locations and extents. S-3 and D-1 are not yet apparent.

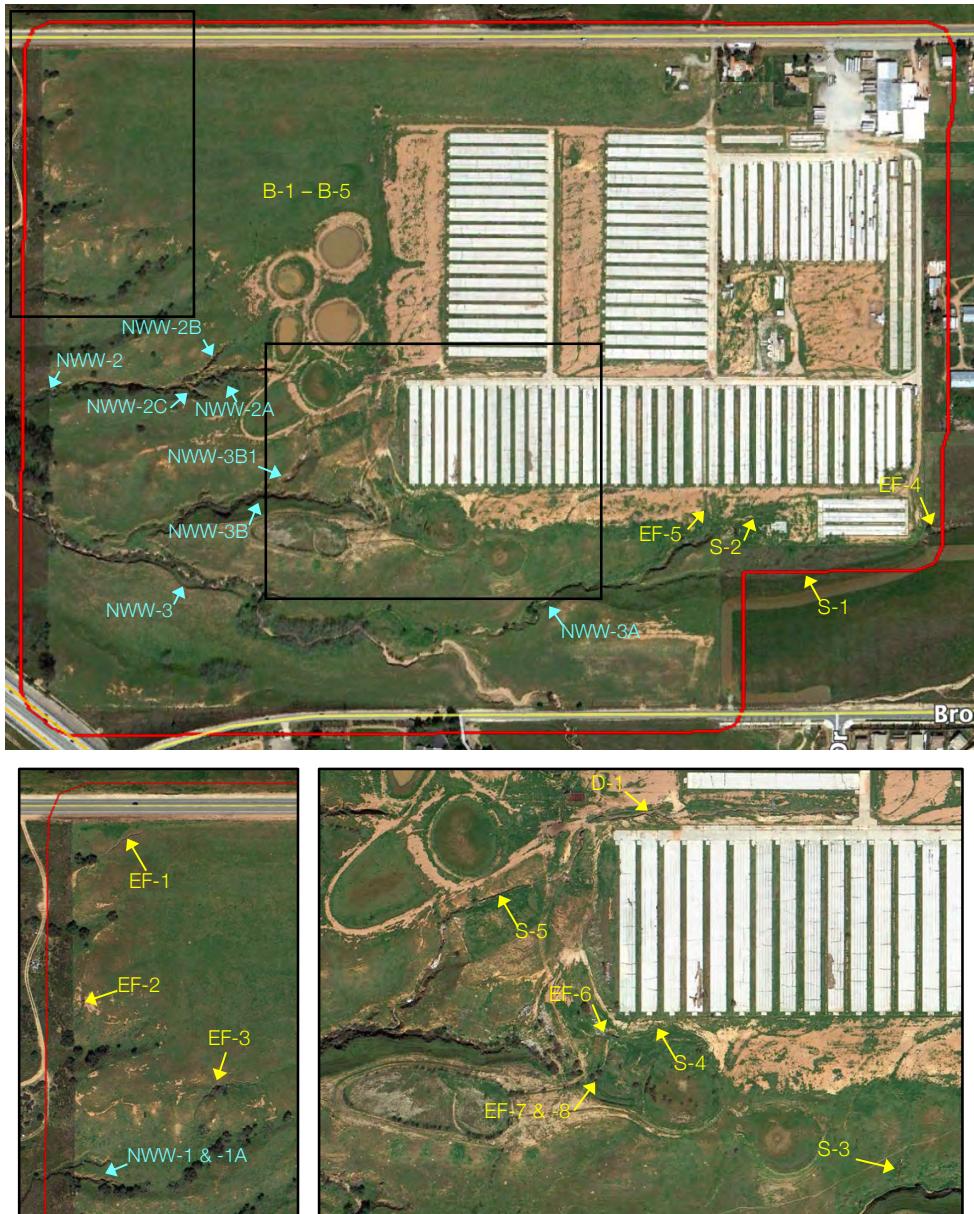
March 2011 – Based on GoogleEarth aerials, the last remaining poultry sheds throughout the review area were removed between January 2006 and August 2006. By March 2011, NWW-1, NWW-1A, NWW-2, NWW-2B, NWW-2C, NWW-3, NWW-3A, NWW-3B, and NWW-3B1 are visible in their current locations and extents. NWW-2A is primarily only visible near its convergence with NWW-2.

B-1 through B5 and EF-1 through EF-4 are visible in their current locations. EF-5 and S-2 are less distinguishable in the May 2011 aerial, likely a result from the total removal of farming operations within the review area. S-1 is still only apparent by the slight concave topography and lacks any other distinguishable features. The end of farming operations also likely contributed to the significant reduction of S-3 between January 2006 and March 2011. S-3 is only slightly evident near its convergence with NWW-3A. EF-6 through EF-8 and S-4 are also less distinguishable in the March 2011 aerial. S-5 and D-1 are still evident in the March 2011 aerial.

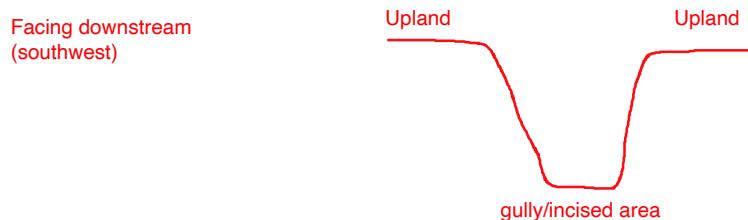
Cross section drawing:

**OHWM**

GPS point: 33.967162, -117.025097

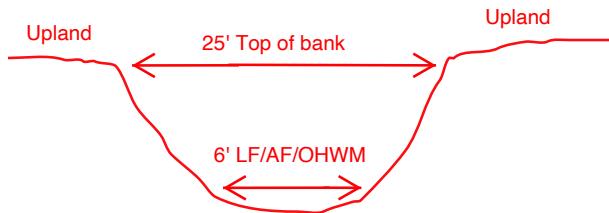
Cross section drawing:

Northern leg of feature; facing downstream (west)

**OHWM**

GPS point: 33.966030, -117.024921

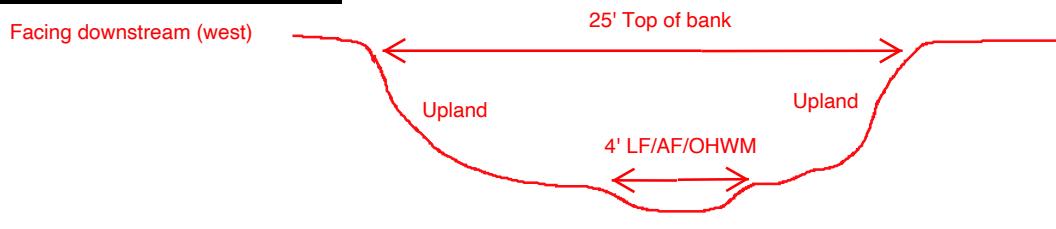
Cross section drawing:

**OHWM**

GPS point: 33.964891, -117.023514

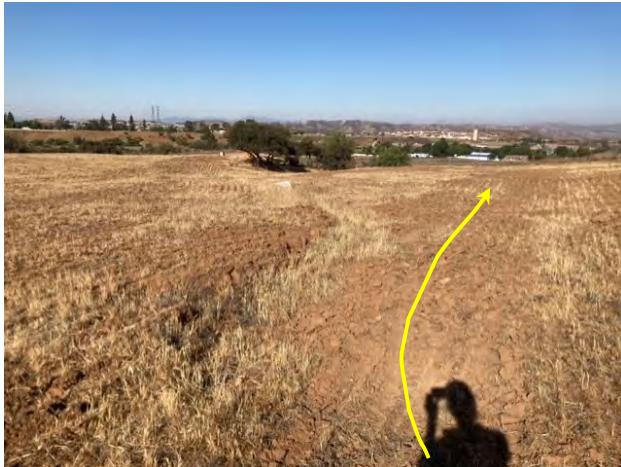
Photo 1. Looking southwest towards Erosional Feature (EF)-1 (yellow line). Vegetation surrounding EF-1 had been recently mowed. EF-1 exhibited a slight break in bank slope, but did not exhibit a distinctive change in average sediment texture, change in vegetation species or cover, or any other Ordinary High Water Mark (OHWM) indicators. (33.968462, -117.024590). June 3, 2021.

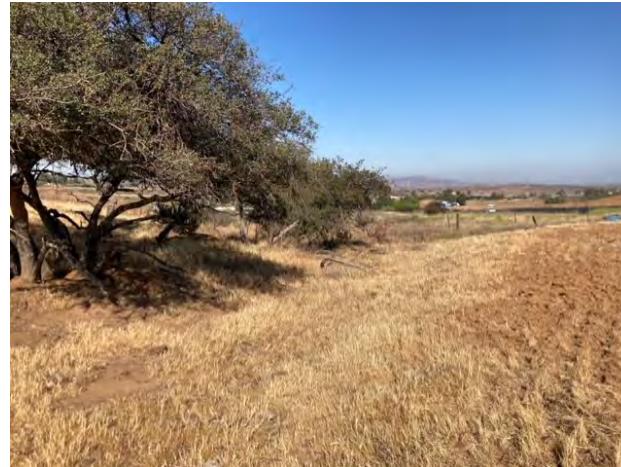
Photo 2. View of OHWM Datasheet Point (ODP) 1, facing west, within the lower topographic area between two gentle slopes just west of EF-1. The lower topographic area did not exhibit any bed and bank indicators, there was no break in slope, and the sediment texture and vegetation did not differ from the lower topographic area to the adjacent slopes (33.968296, -117.024925). June 3, 2021.

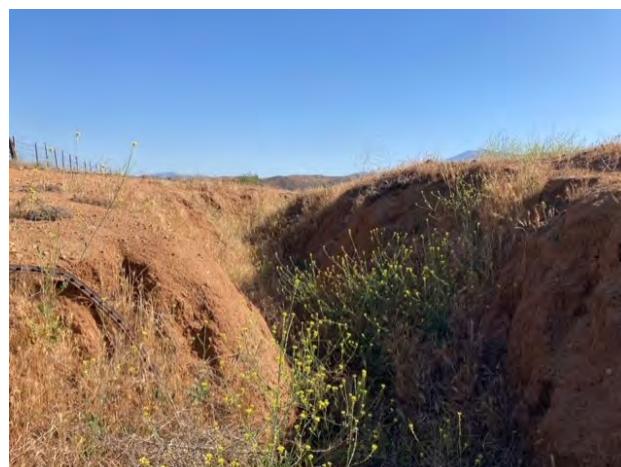
Photo 4. View of ODP 2, facing southwest, within EF-2. The gully/erosional feature exhibited a slight break in bank slope but did not exhibit a distinctive change in average sediment texture, change in vegetation species or cover, or any other OHWM indicators, and did not continue downstream (33.967305, -117.025013). June 3, 2021.

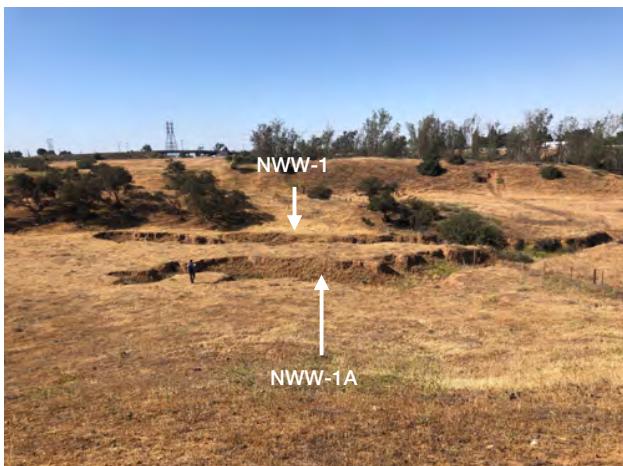
Photo 7. Overview of Non-Wetland Water (NWW)-1A and NWW-1, facing south. NWW-1A and NWW-1 converge just before continuing off site and downstream and exhibiting a more defined bed and bank (33.966304, -117.025167). June 3, 2021.

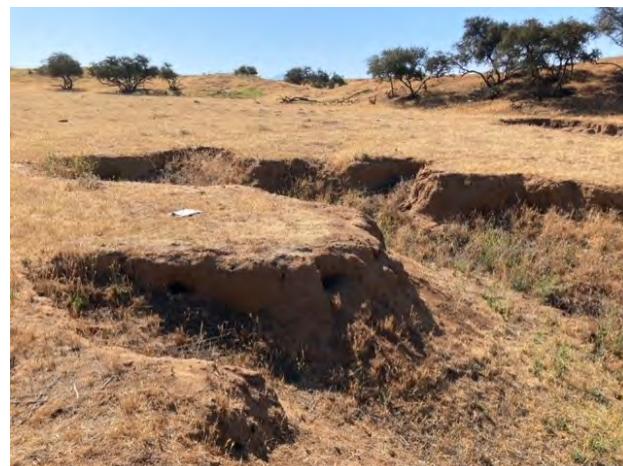
Photo 8. Upstream view of ODP 3, facing southeast, within NWW-1A. The OHWM was defined by a faint break in bank slope and a change in vegetation cover. NWW-1A and NWW-1 continue downstream where OHWM indicators become more prominent (33.966120, -117.025049). June 3, 2021.

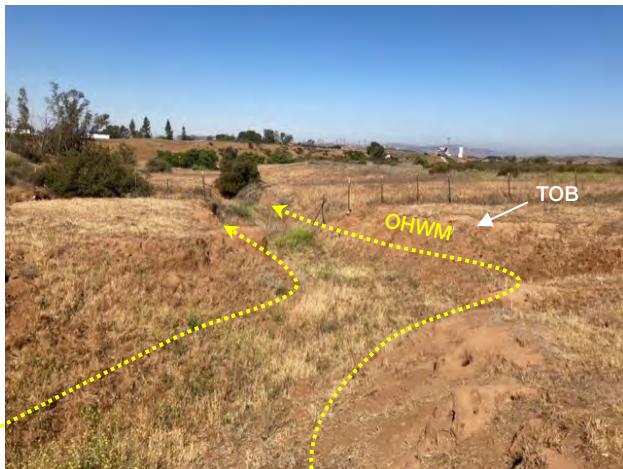
Photo 9. Downstream view of ODP 3, facing west, within NWW-1A. As NWW-1A continues downstream, OHWM indicators become more prominent (33.966076, -117.024773). June 3, 2021.

An OHWM delineation was conducted within the drainage to confirm the presence or absence of OHWM indicators. ODP 3 confirmed the presence of the following OHWM indicators within NWW-1A: a faint break in bank slope and change in vegetation cover between the active floodplain and adjacent uplands (Figures 5A and 5B; Appendix D, ODP 3). WDP 2 (see *Non-Wetland Water 2* below) was representative of the conditions in NWW-1A. Based on the data collected, the estimated OHWM measured approximately 6 feet wide throughout the extent of NWW-1A.

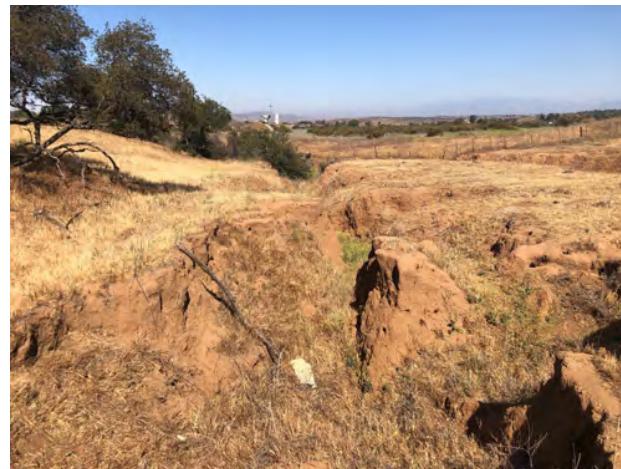
Photo 10. Downstream view of NWW-1 from upstream extent, facing west. As NWW-1 continues downstream, OHWM indicators become more prominent (33.965835, -117.024734). June 3, 2021.

OHWM Datasheet Point (ODP) 3 (see *Non-Wetland Water 1A* below) represents the OHWM within NWW-1 given the similar conditions observed within NWW-1A; similarly, WDP 2 (see *Non-Wetland Water 2* below) provides representative wetland delineation data for NWW-1 given the similar conditions observed within NWW 2. The estimated OHWM within NWW-1 measured approximately 4 feet wide until NWW-1 converged with NWW-1A, at which point the OHWM

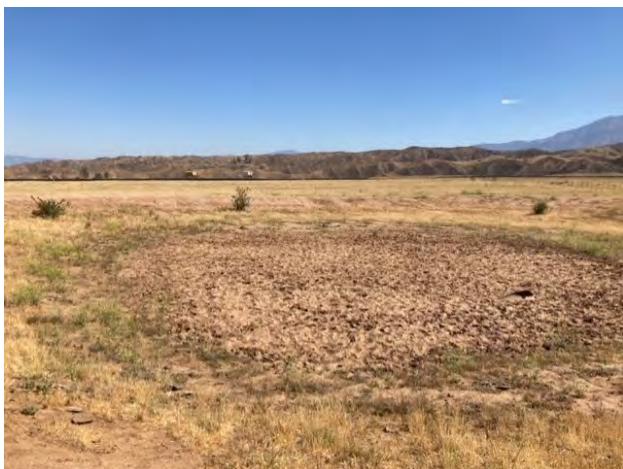
Photo 11. View of B-1, which contained several mulefat (*Baccharis salicifolia*), facing north. B-1 was previously used as a settling basin to hold manure (33.966130, -117.021422). June 3, 2021.

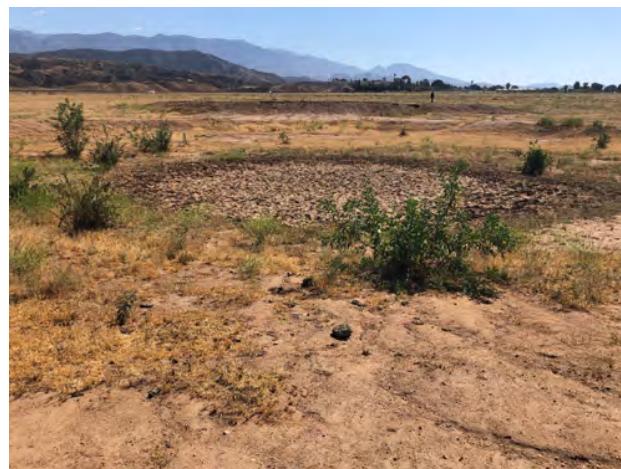
Photo 12. View of B-2, which contained some mulefat and tree tobacco (*Nicotiana glauca*), facing northeast. B-2 was previously used as a settling basin to hold manure (33.966130, -117.021422). June 3, 2021.

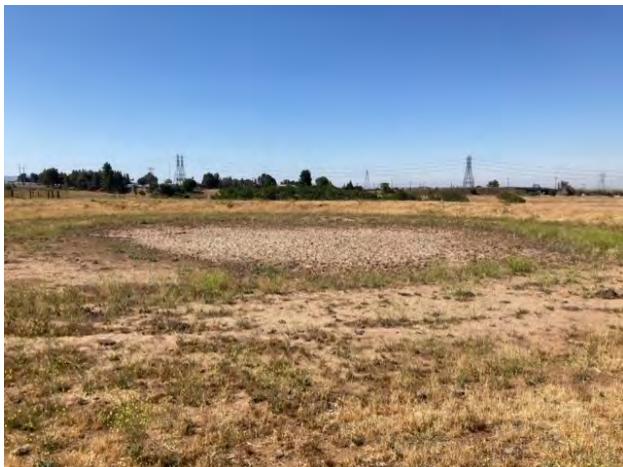
Photo 13. View of B-3, facing south. B-3 was previously used as a settling basin to hold manure (33.965818, -117.021455). June 3, 2021.

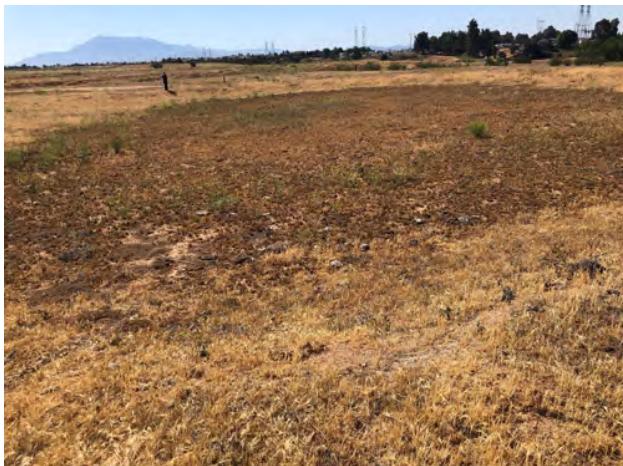
Photo 15. View of B-5 facing southeast. B-5 was previously used as a settling basin to hold manure (33.965122 -117.021874). June 3, 2021.

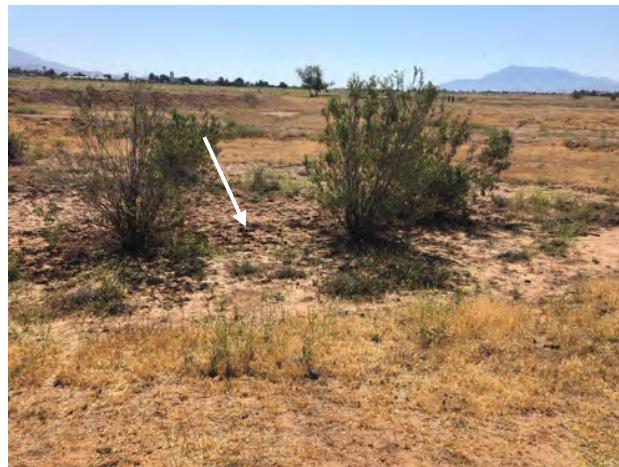
Photo 14. View of Wetland Data Form Point (WDP) 1 (white arrow) within small stand of mule fat, facing east, within B-4. WDP 1 met the wetland hydrology parameter; however, hydrophytic vegetation and hydric soil parameters were not met at WDP 1. B-4 was previously used as a settling basin to hold manure (33.965370, -117.022221). June 3, 2021.

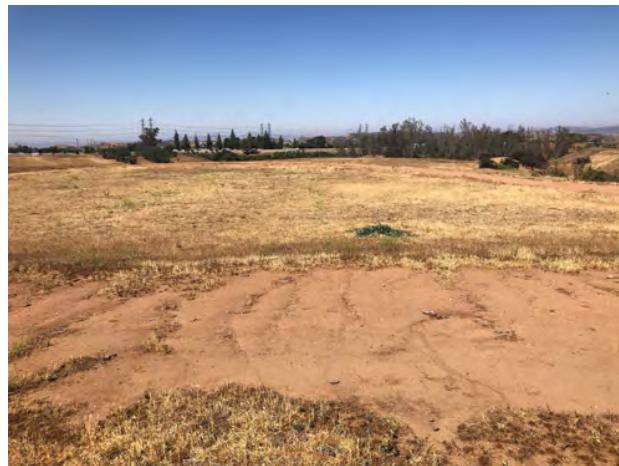
Photo 16. View of area mapped by U.S. Geological Survey (USGS) National Hydrography Dataset (NHD) as a "Reservoir," facing west. No evidence of hydrology was observed (33.965010, -117.021979). June 3, 2021.

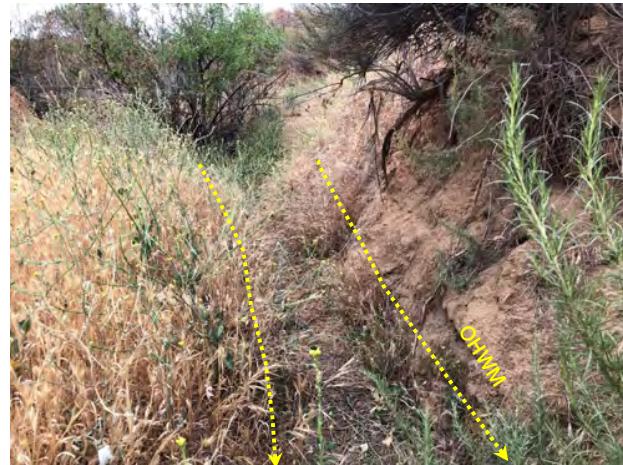
Photo 18. Upstream view of ODP 4, facing east, within NWW-2. The OHWM was defined by a faint break in bank slope and a change in vegetation cover (33.964853, -117.023670). June 7, 2021.

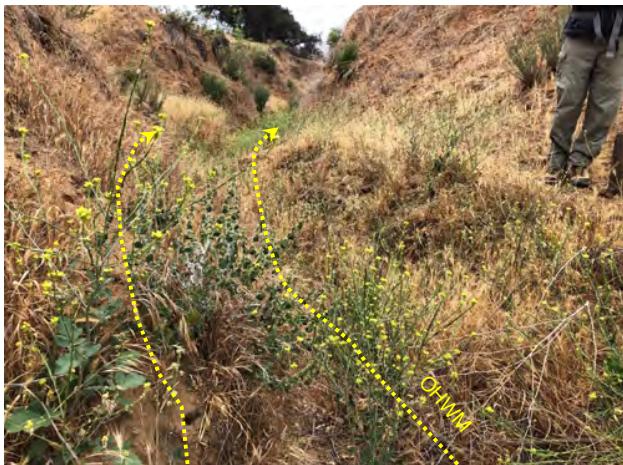
Photo 19. Downstream view of ODP 4, facing west, within NWW-2. Vegetation was dominated by non-native grasses, including short-pod mustard (*Hirschfeldia incana*), ripgut brome (*Bromus diandrus*), and false brome (*Brachypodium distachyon*) (33.964874, -117.023356). June 7, 2021.

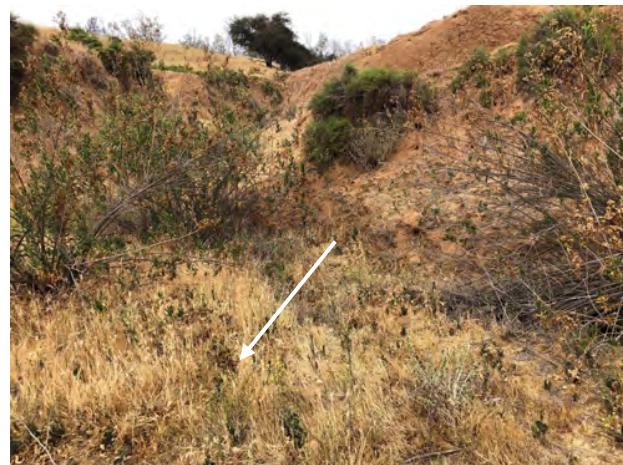
Photo 20. View of WDP 2 (white arrow), facing west, within NWW-2. WDP 2 did not meet the hydrophytic vegetation, hydric soil, or wetland hydrology parameters (33.964962, -117.023251). June 7, 2021.

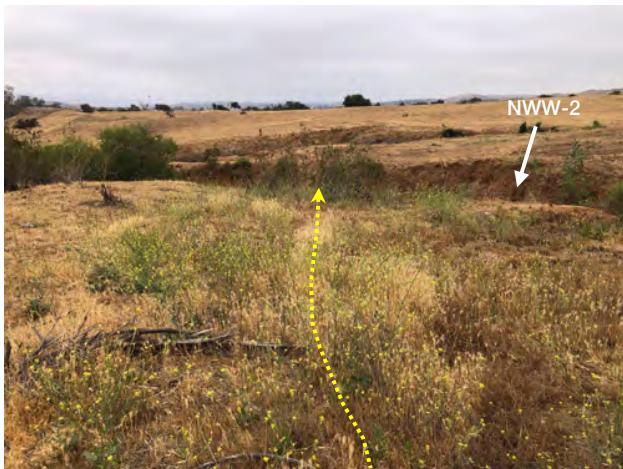
Photo 21. View of NWW-2A (yellow line), which showed faint indicators of an OHWM, as it continues into NWW-2, facing northwest (33.964876, -117.022516). June 7, 2021.

ODP 4 (see *Non-Wetland Water 2* above) was representative of the OHWM in NWW-2A. WDP 2 (see *Non-Wetland Water 2* above) was representative of the conditions in NWW-2A. Based on the data collected, the estimated OHWM measured approximately 1 foot wide.

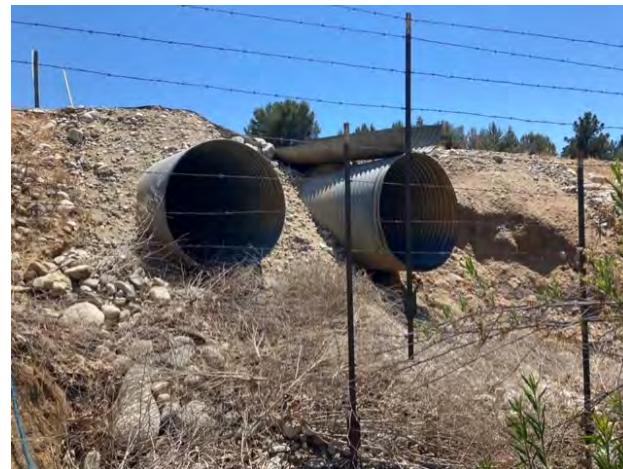
Photo 22. View of culvert outlets located along the southern extent of the review area under Brookside Avenue, facing south. Flows from the culvert outlets continue into NWW-3 (33.961603, -117.018517). June 3, 2021.

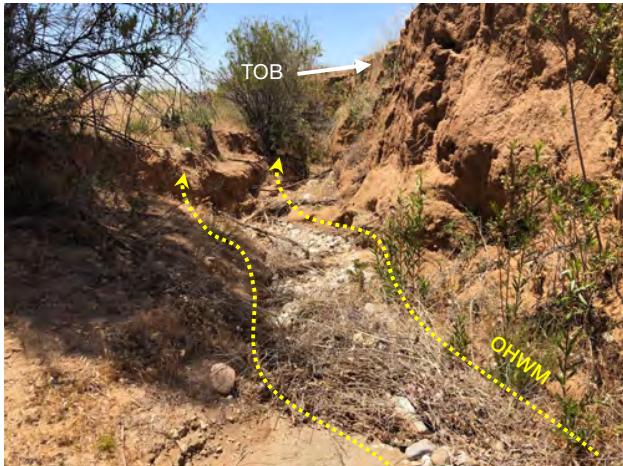
Photo 23. Downstream view of NWW-3, facing northwest, located just north of the two culvert outlets under Brookside Avenue before NWW-3 converges with NWW-3A (33.961636, -117.018604). June 3, 2021.

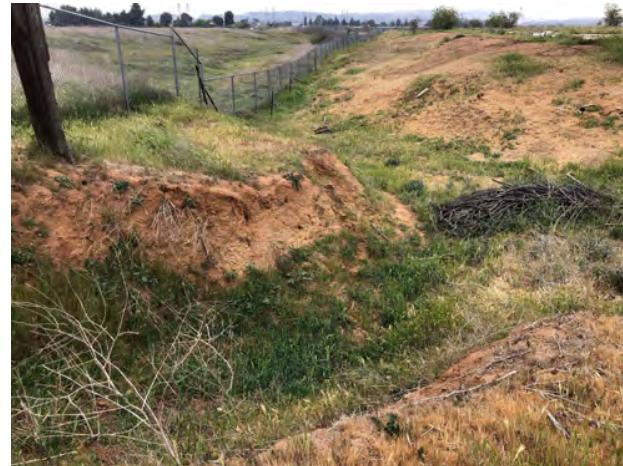
Photo 24. View of EF-4 within the review area, facing west. EF-4 continues west into Swale (S)-1, which ultimately converges with NWW-3A (33.963245, -117.013837). April 22, 2021.

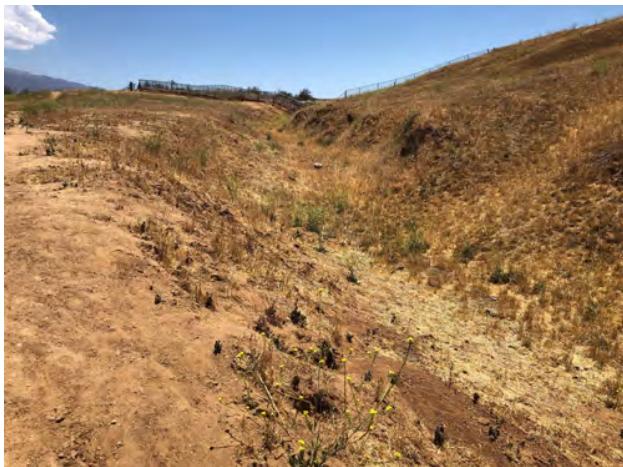
Photo 25. View of ODP 6, facing east, within S-1. S-1 did not exhibit any bed and bank indicators, there was no change in sediment texture or break in slope, and vegetation did not differ between the swale and the adjacent upland area (33.962812, -117.017420). June 3, 2021.

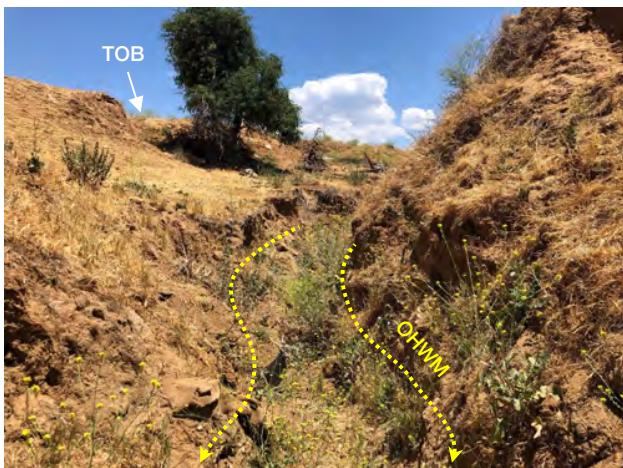
Photo 27. Upstream view of ODP 5, facing northeast, within NWW-3A. The OHWM was primarily defined by a a break in bank slope, change in average sediment texture, and change in vegetation species (33.963053, -117.017202). June 3, 2021.

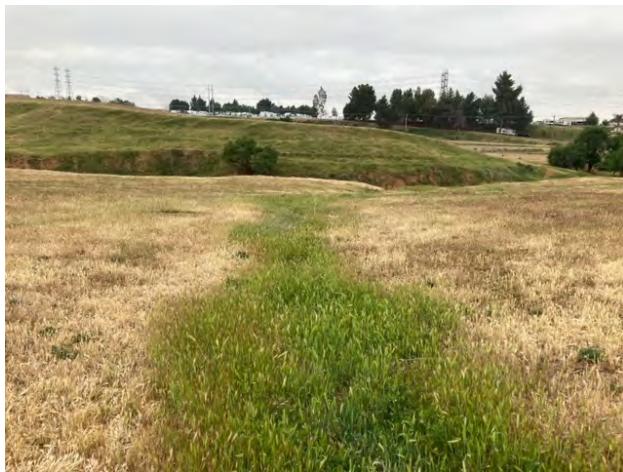
Photo 29. View of S-3, facing south, as it travels towards NWW-3A (33.9632961, -117.018316). April 22, 2021.

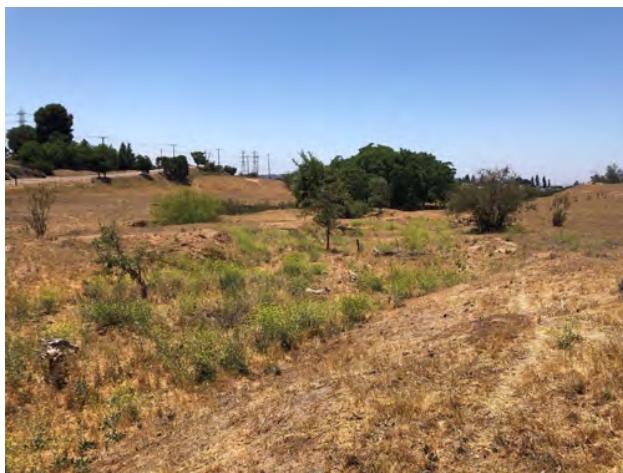
Photo 31. Downstream view of area of NWW-3A exhibiting a faint OHWM, facing west (33.962373, -117.019364). June 3, 2021.

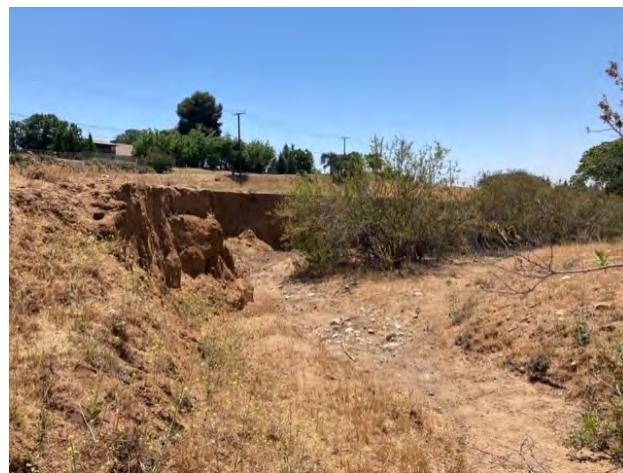
Photo 32. Downstream view of NWW-3, located west of the convergence of NWW-3 and NWW-3A, facing southwest (33.962054, -117.02037). June 3, 2021.

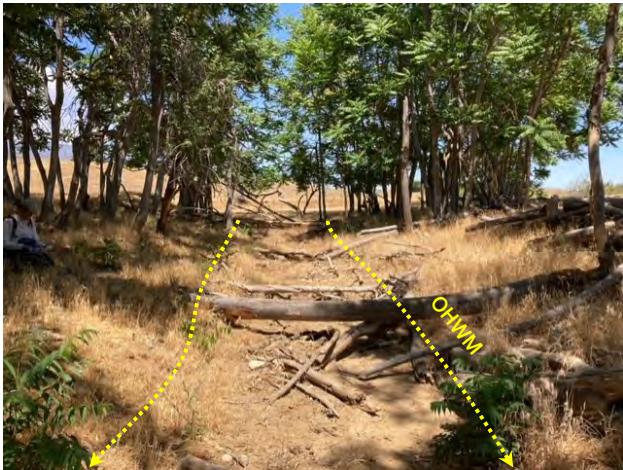
Photo 33. Upstream view of ODP 7, facing east, within NWW-3. The OHWM was primarily defined by a change in average sediment texture, change in vegetation species and cover, and faint break in bank slope (33.962257, -117.021513).

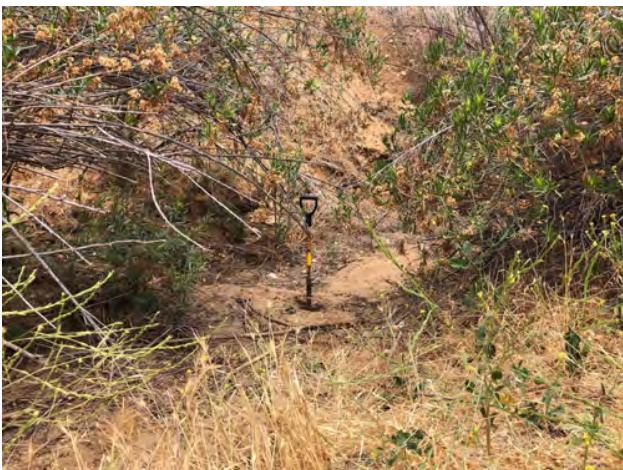
Photo 35. View of WDP 3, facing north, within NWW-3. WDP 3 met the hydrophytic vegetation parameter; however, hydric soil and wetland hydrology parameters were not met within WDP 3 (33.962696, -117.022892). June 7, 2021.

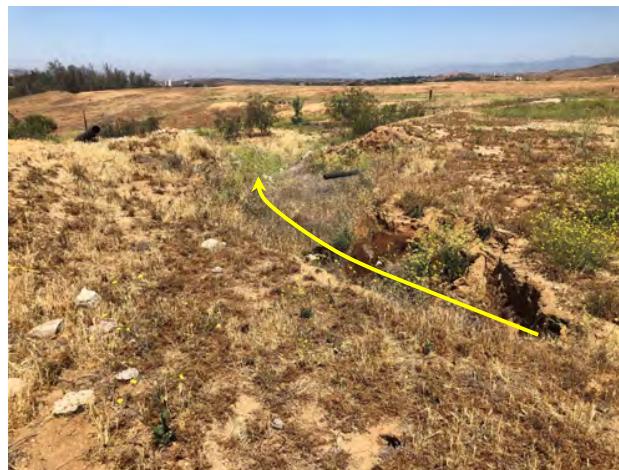
Photo 36. View of EF-6 (yellow line), facing northwest, which travels into area with some mulefat and tree tobacco, just east of NWW-3B. EF-6 did not appear to contribute flows to NWW-3B (33.963667, -117.020341). June 3, 2021.

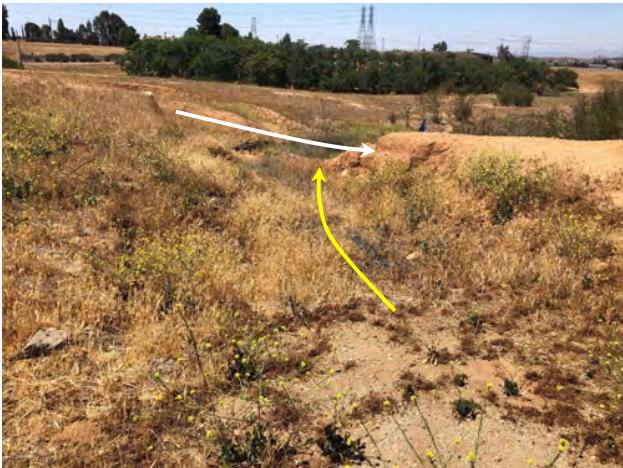
Photo 37. View of EF-7 (yellow arrow), just south of EF-6, facing south/southwest. EF-7 converges with EF-8 (white arrow), neither of which appeared to contribute flows to NWW-3B (33.963581, -117.020494). June 3, 2021.

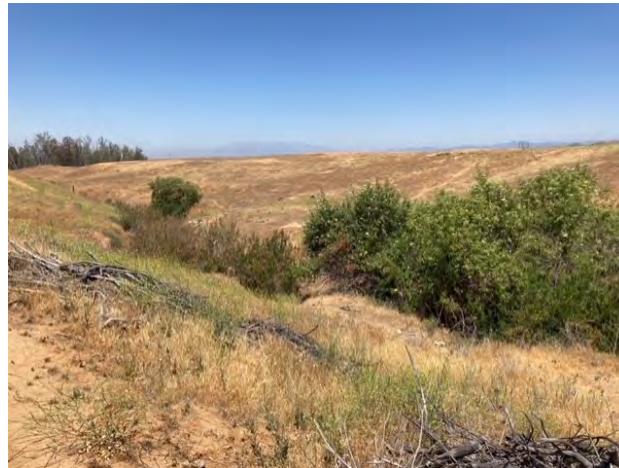
Photo 38. Looking downstream from the south side of the upstream extent of NWW-3B, facing northwest (33.963553, -117.021142). June 3, 2021.

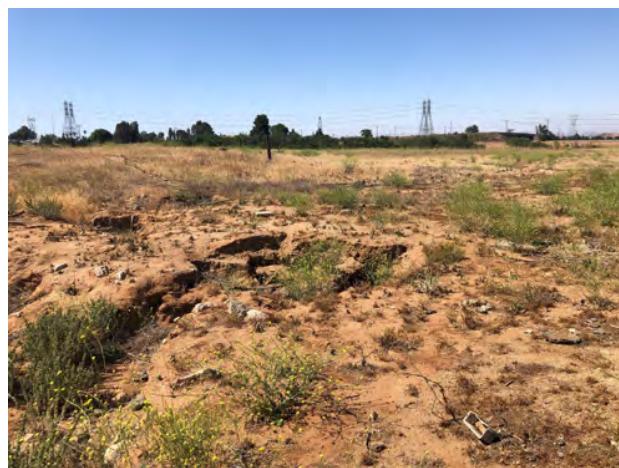
Photo 40. View of area where D-1 abruptly stops, facing south. Flows likely continue as sheet flow into S-5, before continuing into NWW-3B1 (33.964824, -117.020845). June 3, 2021.

D-1 (Figures 5A to 5C) is an earthen-bottom ditch that is located in the center of the review area, within the former locations of the poultry sheds. D-1, which is located within an area of non-native grassland, appears to have initiated as runoff from underneath a concrete slab associated with the poultry sheds, then continues west before traveling through a culverted pipe and becoming more incised at several points before abruptly terminating (see Appendix F, Photo 40). Based on the established vegetation and a review of historic aerials (Appendix C), D-1 is an abandoned ditch that was created between May 2002 and June 2003 to convey runoff away from the poultry sheds. D-1 displayed a break in bank slope but did not exhibit a distinctive change in average sediment texture, change in vegetation species or cover, or any other other OHWM indicators. Vegetation within the ditch was well established and contained some refuse from the former agricultural operations, indicating that this ditch likely no longer receives flows and does not convey flows downstream into NWW-3BA.

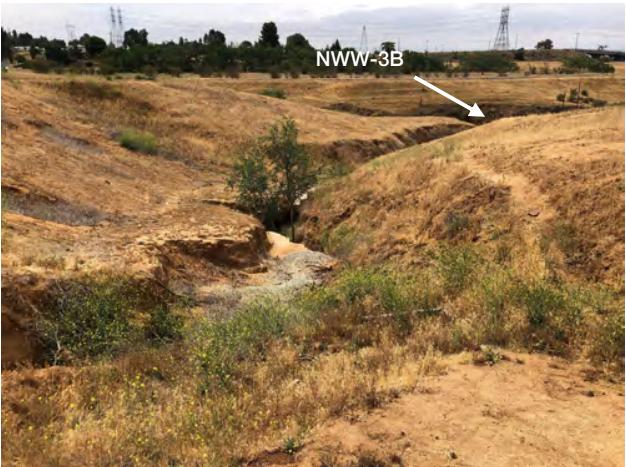
Photo 41. View of NWW-3B1, facing south. Flows continue south/southwest into NWW-3B (white arrow) (33.964550, -117.021793). June 3, 2021.

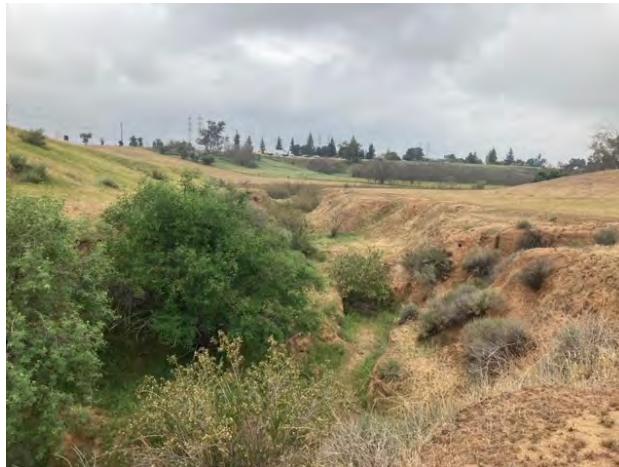
Photo 42. Downstream view of NWW-3B, facing west (33.963775, -117.022856). April 22, 2021.

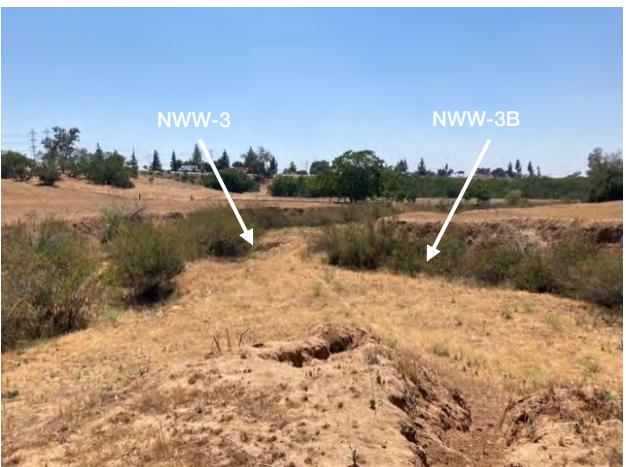
Photo 43. Downstream view of the convergence of NWW-3 and NWW-3B, facing west, before NWW-3 continues off site (33.963316, -117.023726). June 3, 2021.

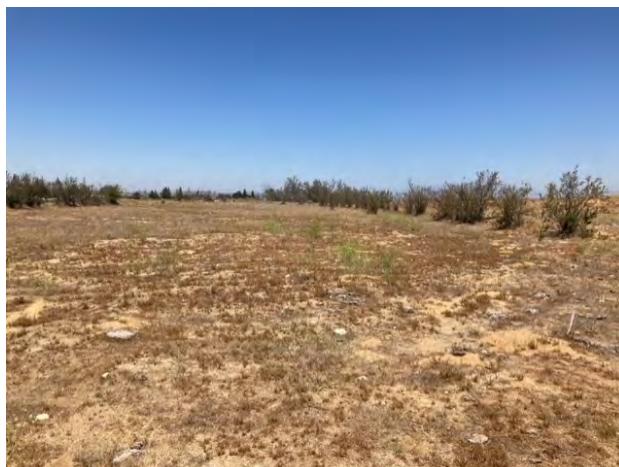
Photo 44. View of slight depressional area surrounded by mulefat scrub, located south of NWW-3B, facing west. No evidence of hydrology was observed (33.963283, -117.021269). June 3, 2021.

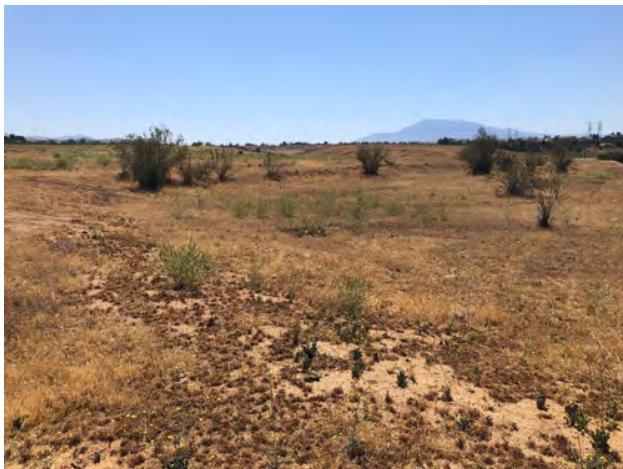
Photo 45. East facing view of area mapped by USGS NHD as a "Reservoir" and where a basin was previously located east of EF-8. No evidence of hydrology was observed (33.963493, -117.020227). June 3, 2021.

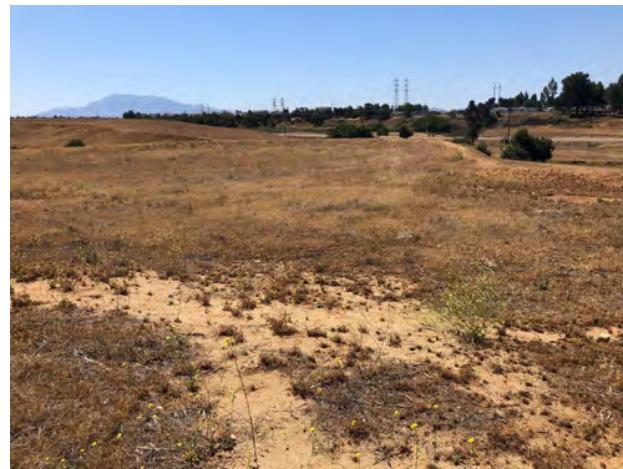
Photo 46. Southeast facing view of area where a basin was previously located west of S-3. No evidence of hydrology was observed (33.963274, -117.019648). June 3, 2021.

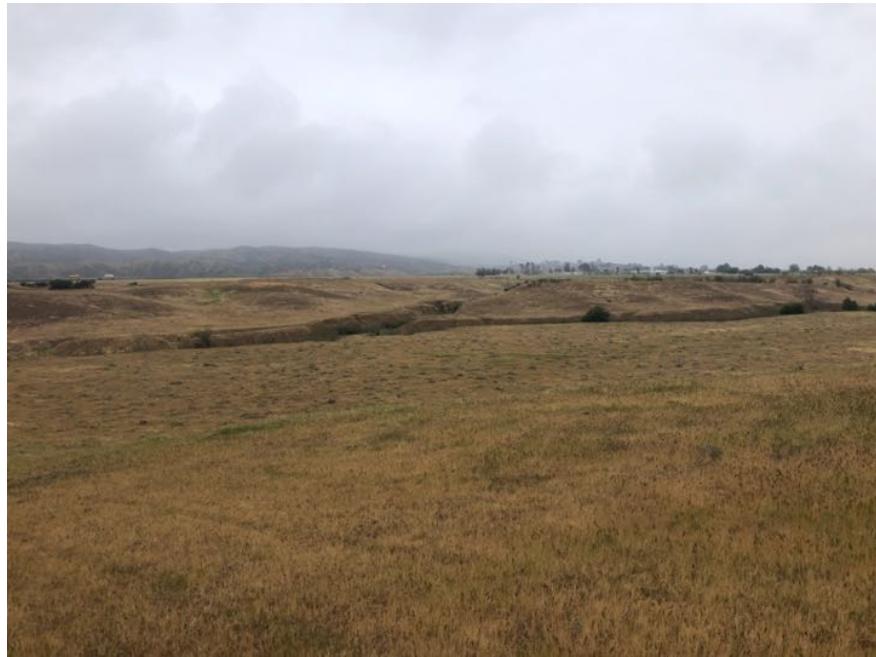
Photo 1. Overview of project site from the western site boundary, showing drainages running through non-native grassland, facing northeast on April 22, 2021.

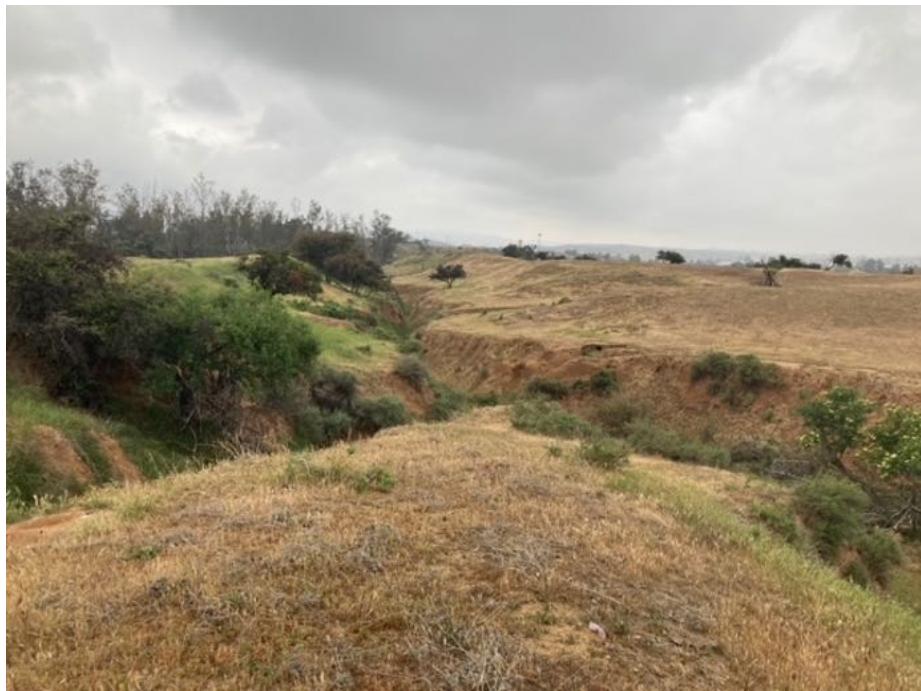
Photo 2. View of non-native grassland in the western portion of the project site, showing oaks and drainages containing mulefat, facing west on April 22, 2021.

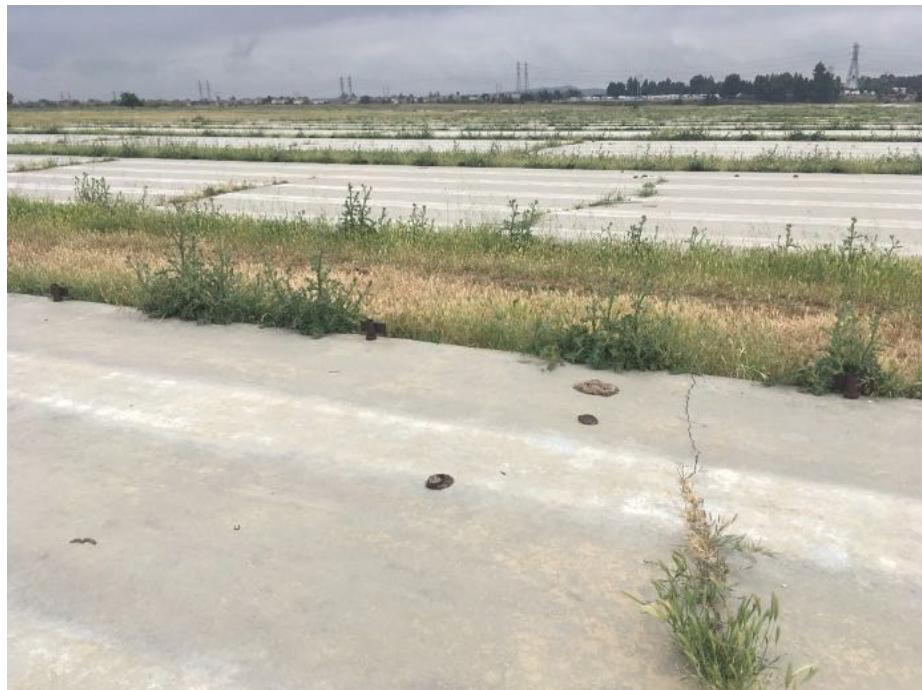
Photo 4. Picture of concrete pads within the central portion of the project, facing south on April 22, 2021.

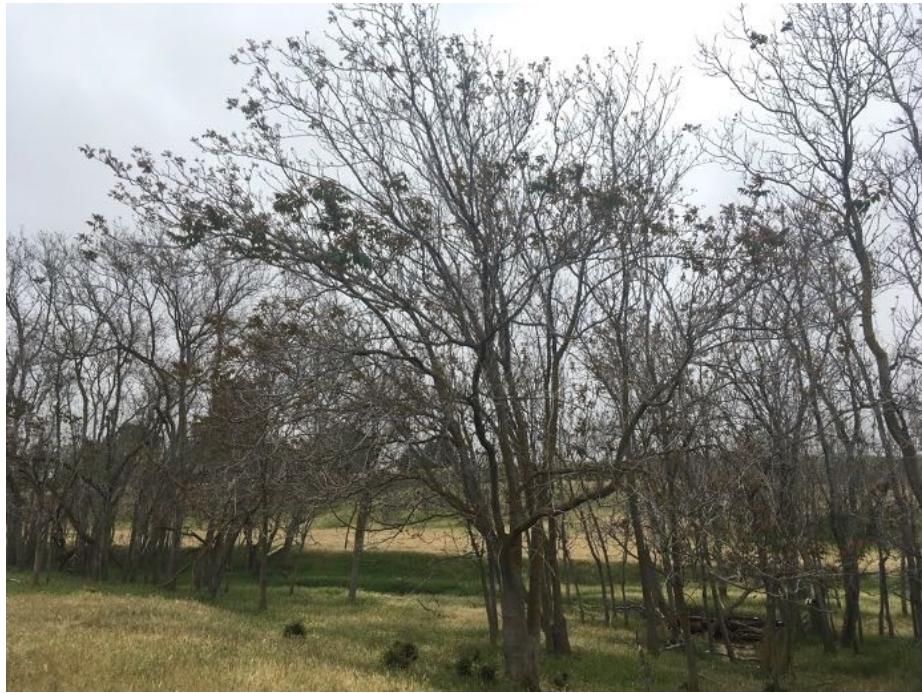
Photo 5. Representative photos from April 22, 2021 of the non-native riparian (*Ailanthus altissima*) within the drainages in the southwestern portion of the site; stands have a height of up to approximately 25 feet.

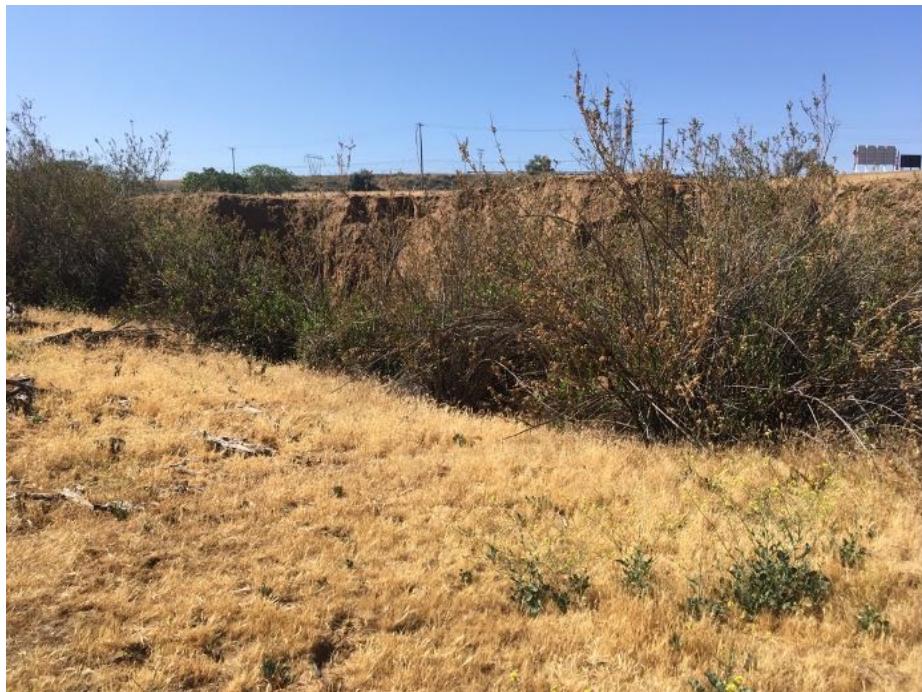
Photo 6. South-facing view of mulefat scrub within the drainages in the southwestern portion of the site, facing west on May 27, 2021.

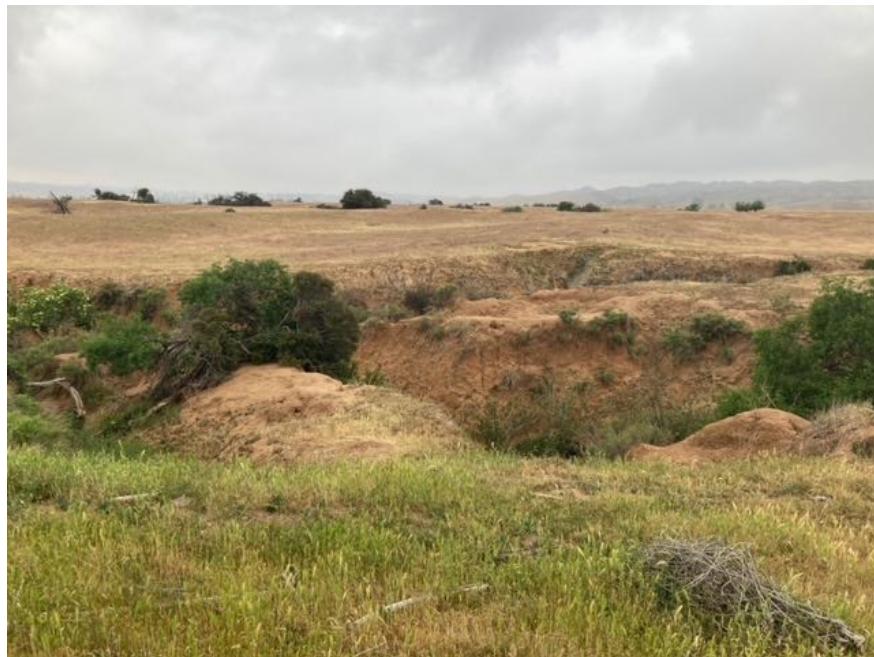
Photo 7. Representative picture of the drainages within the southwestern portion of the project site, facing east on April 22, 2021.

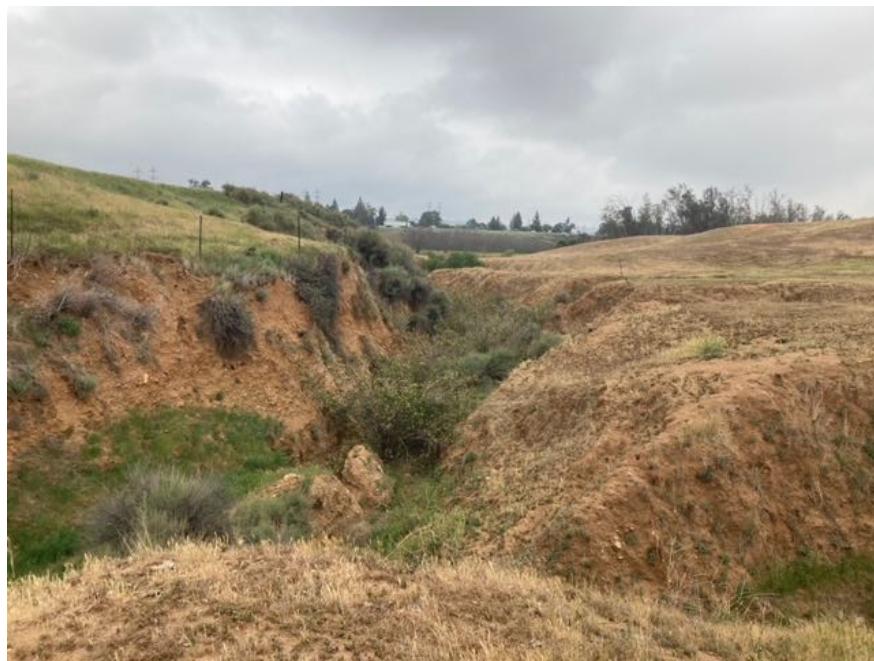
Photo 8. Representative picture of the drainages within the southwestern portion of the project site, facing north on April 22, 2021.

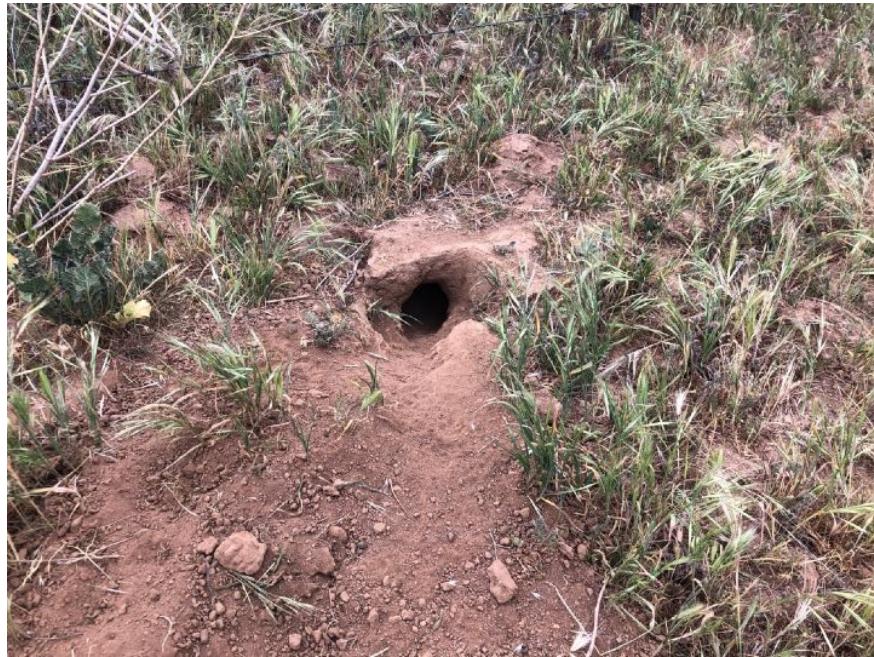
Photo 9. Representative photo of the small-mammal burrows throughout the non-native grassland within the survey area.
