**APPENDIX D – JURISDICTIONAL DELINEATION REPORT**

**JURISDICTIONAL DELINEATION REPORT  
FOR THE CHERRY CHANNEL DRAINAGE  
PROJECT  
BEAUMONT, CALIFORNIA**

**CITY OF BEAUMONT**  
550 E 6<sup>th</sup> Street  
Beaumont, California 92223

**CHAMBERS GROUP, INC.**  
3151 Airway Avenue, Suite F208  
Costa Mesa, CA 92626

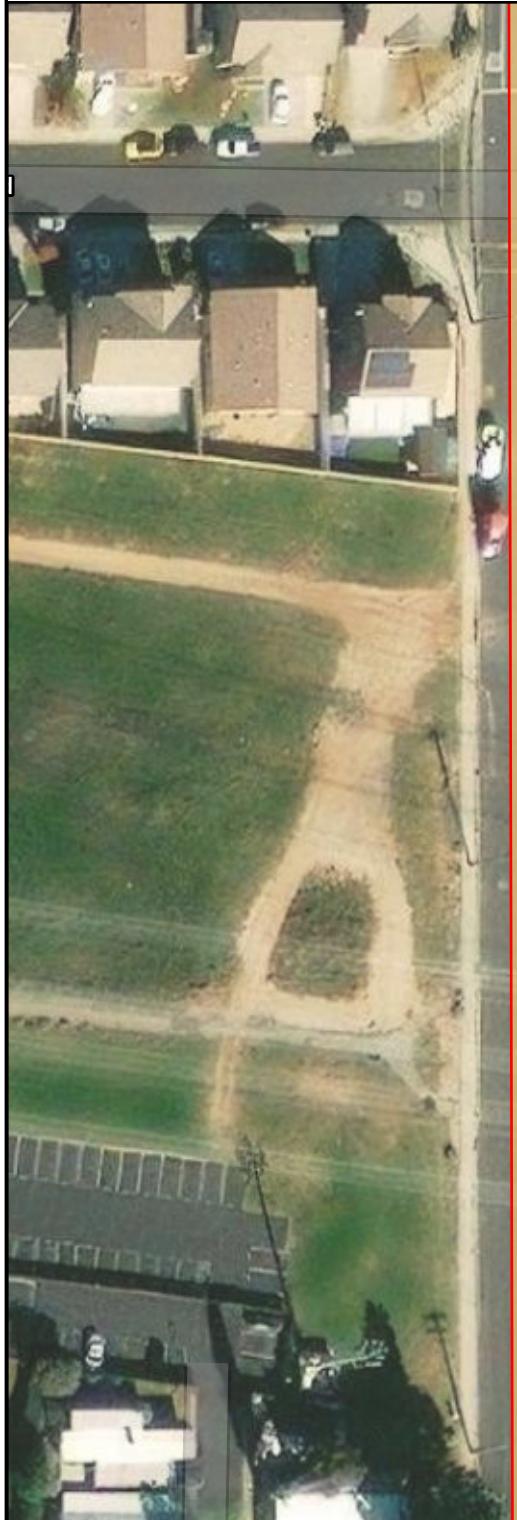
**Figure 4**  
Cherry Channel Drainage  
Vegetation Communities

Vegetation Communities

- Cattail Marsh
- Developed
- Disturbed Wild Tarragon Patches
- Disturbed Goodding's Willow-Red Willow Riparian Woodland
- Ornamental
- Ruderal

Six vegetation communities were mapped within the Project site, including Cattail Marsh, Disturbed Goodding's Willow - Red Willow Riparian Woodland, Wild Tarragon Patches, Ruderal, Ornamental, and Developed. Vegetation mapped during the delineation is provided in Figure 4.

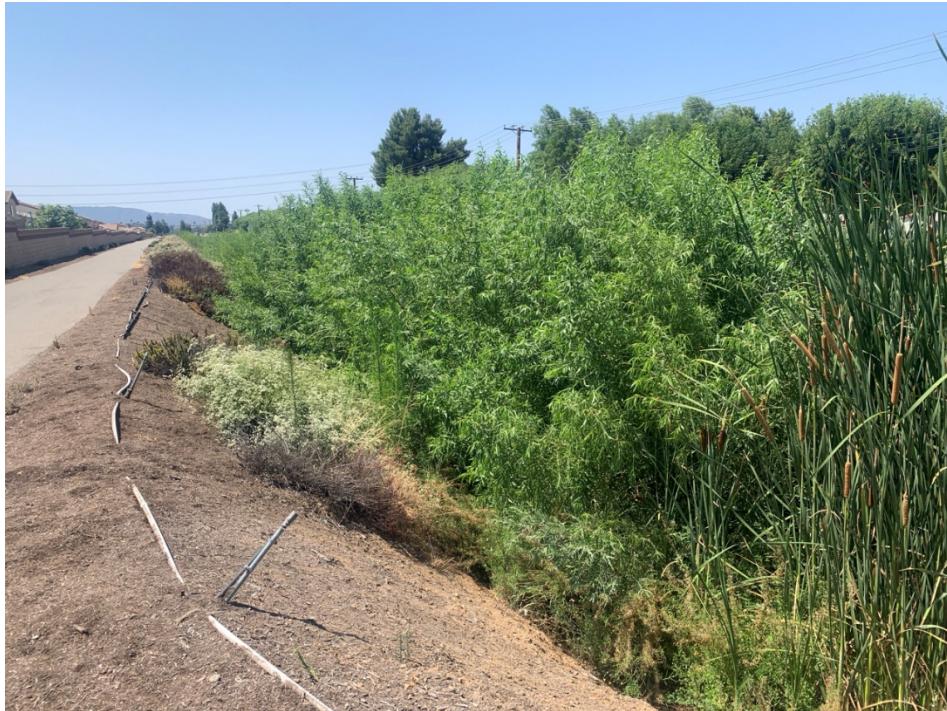
**Photo 1.**

Overview photo of Cherry Channel drainage from the north end. The northern half of the drainage is dominated by young Goodding's Willow Riparian habitat. Photo is facing south.

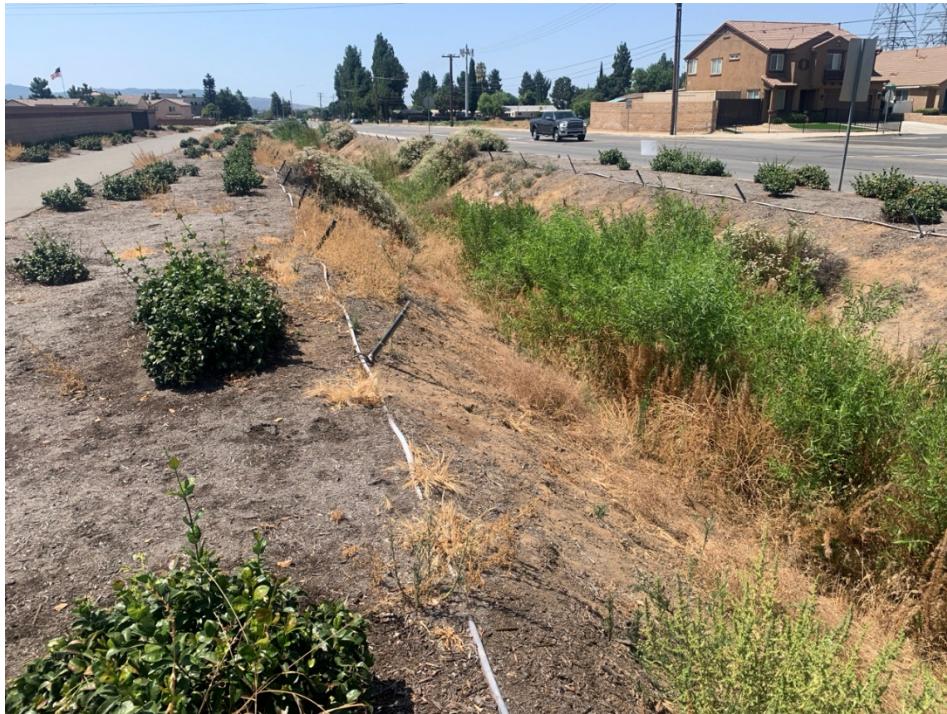
**Photo 2.**

Overview photo of Cherry Channel drainage from the middle of the Project site. Disturbed Goodding's Willow Riparian habitat begins to transition into cattail marsh habitat. Photo is facing south.

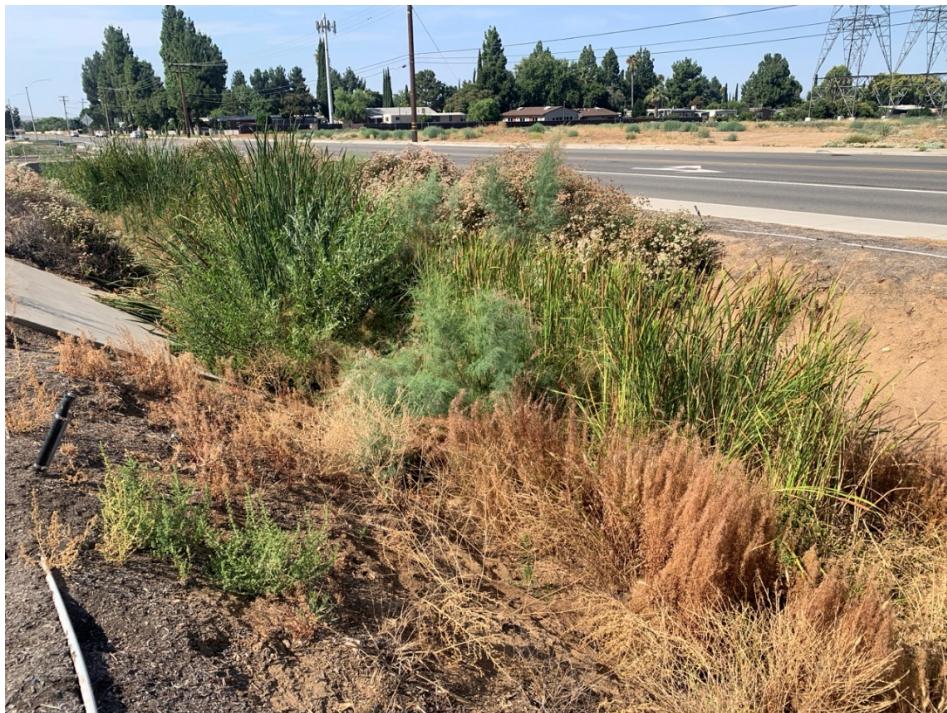
**Photo 3.**  
Cattail marsh habitat with Ruderal vegetation lining the slopes located near the middle of the drainage. Photo is facing southwest.

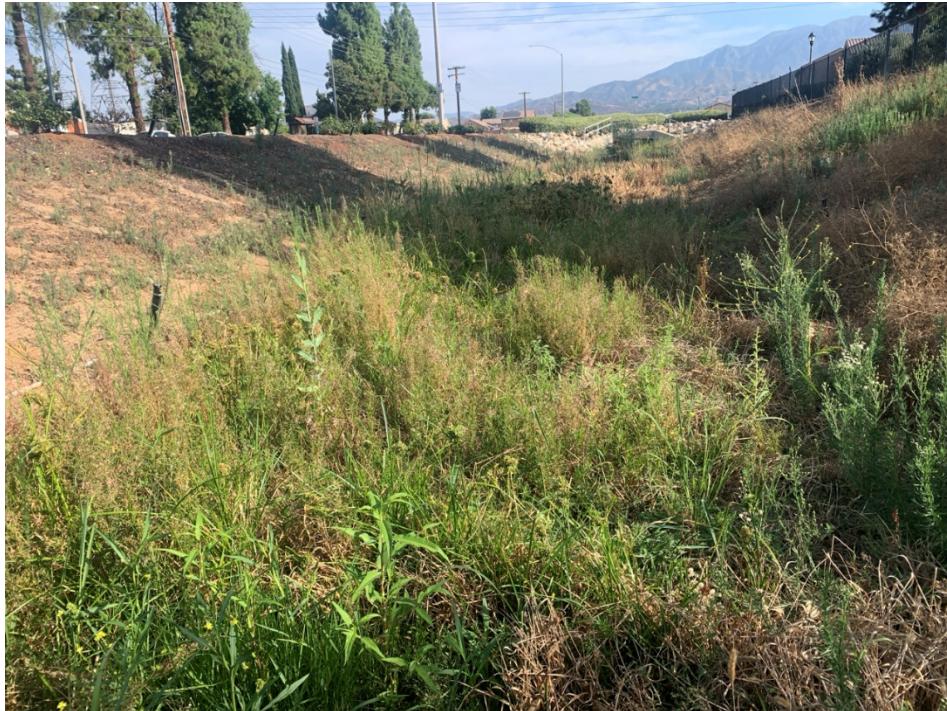
**Photo 4.**  
Section on the southern half of the drainage that is dominated by Disturbed Wild Tarragon habitat. Slopes of the drainage are Ruderal with scattered natives including horseweed and California buckwheat. Photo is facing north.

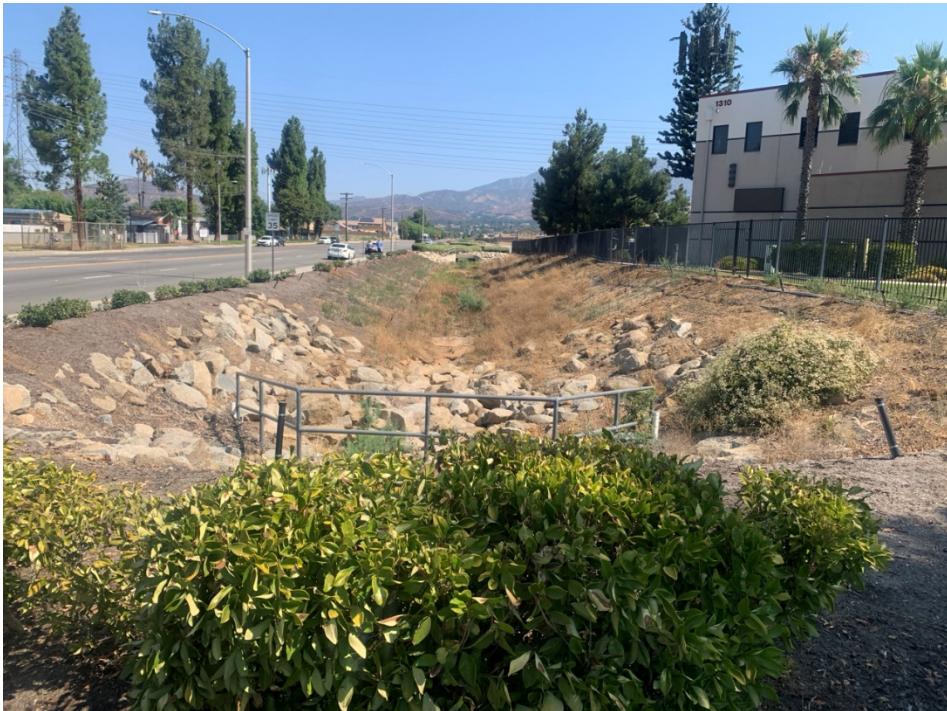
**Photo 5.**

Overview of the southern portion of the drainage. This area is dominated with Ruderal vegetation. Ornamental vegetation lines the outsides of the channel. Photo is facing north.

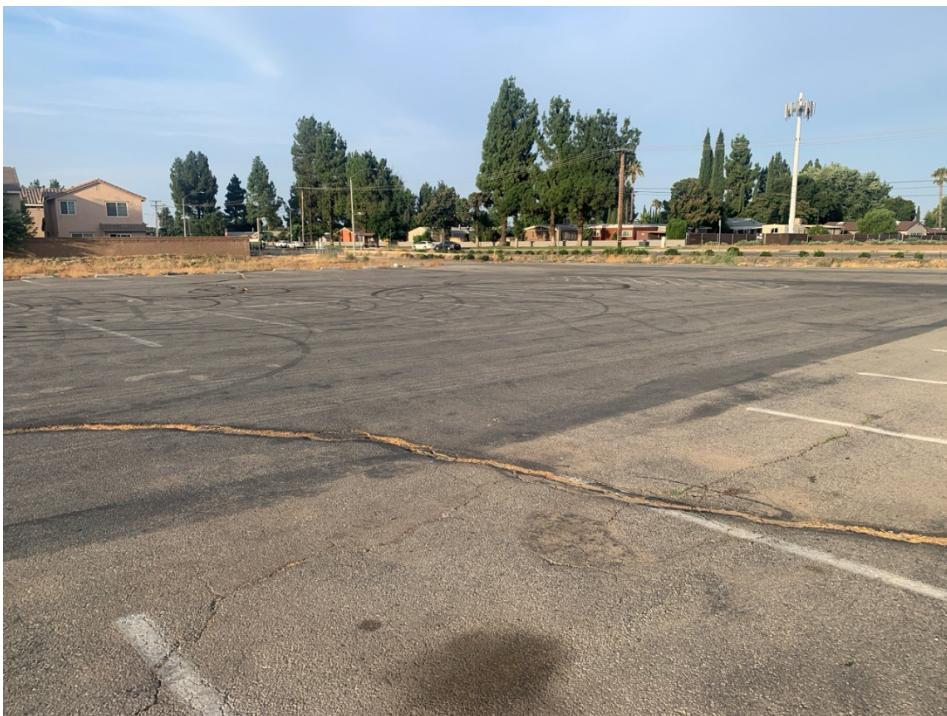
**Photo 6.**

Overview photo of the parking lot located east of the drainage. More Ruderal vegetation is located on both sides of the Parking lot. Photo is facing southwest.

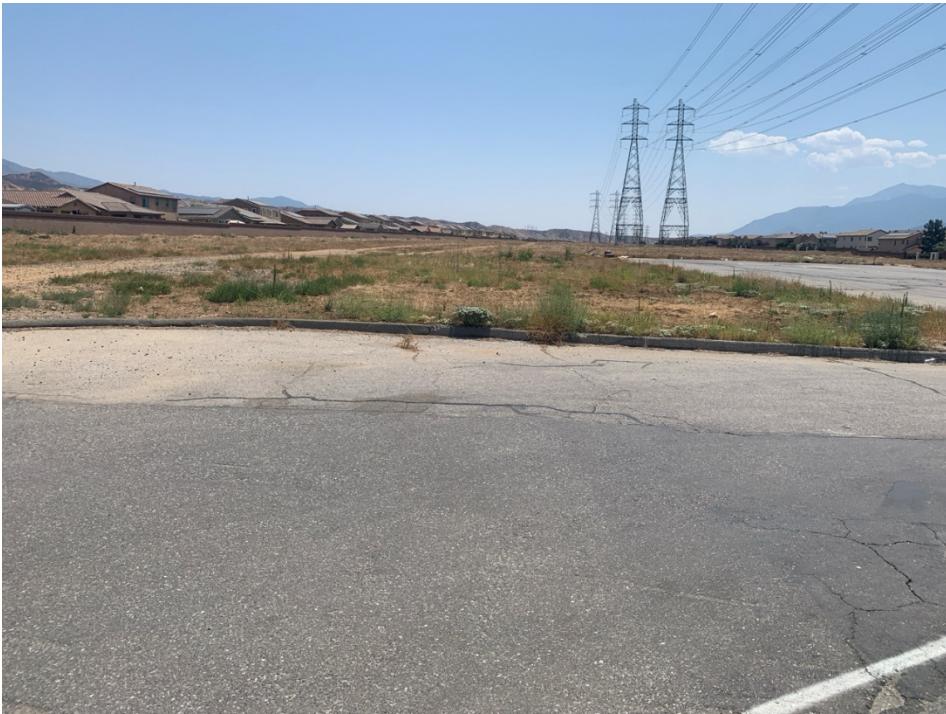
**Photo 7.**

Overview of the open space located along the SCE power lines. This area has a low potential for BUOW. Soils look freshly tilled/mowed. Photo is facing east.

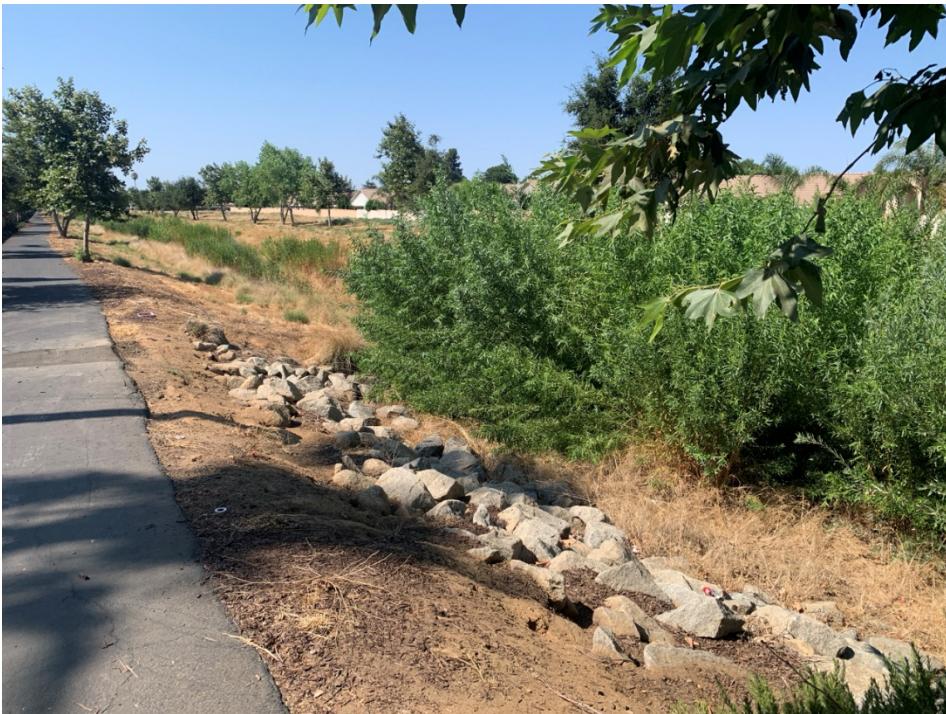
**Photo 8.**

Overview photo of the natural drainage (Potrero Creek) located south, outside of the Project site boundary. This drainage leads to San Jacinto River which is a NWI mapped waterway. Photo is facing southwest.
