## **APPENDIX B – BIOLOGICAL TECHNICAL REPORT**

**BIOLOGICAL TECHNICAL REPORT FOR THE  
CHERRY CHANNEL DRAINAGE PROJECT  
CITY OF BEAUMONT, CALIFORNIA**

**CHAMBERS GROUP, INC.**  
3151 Airport Avenue, Suite F208  
Costa Mesa, California 92626  
(949) 261-5414

**November 2024**

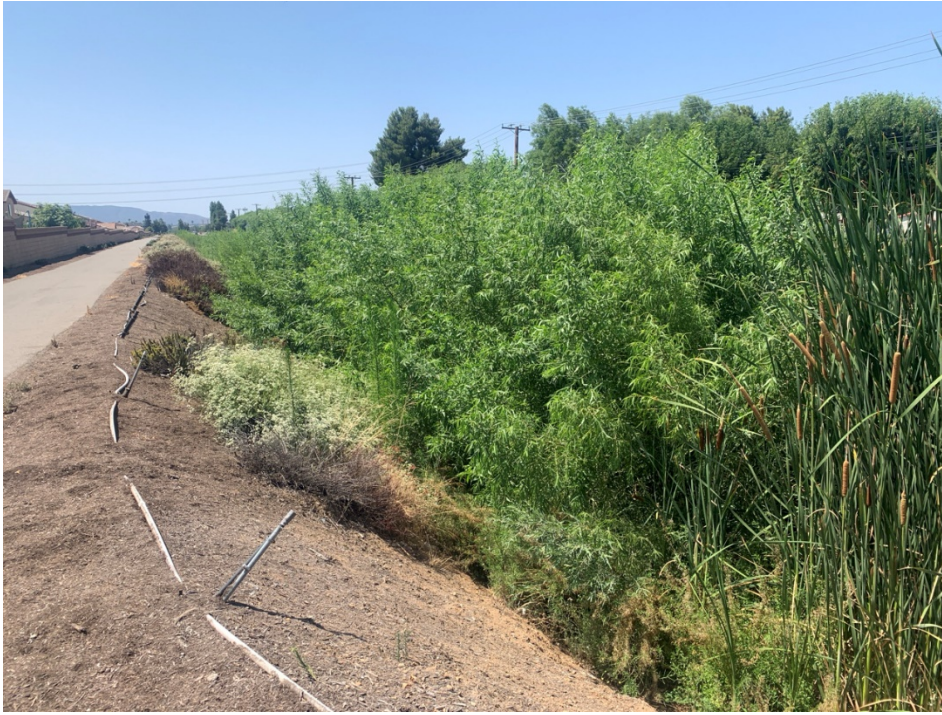
**Photo 1.**

Overview photo of Cherry Channel drainage from the north end. The northern half of the drainage is dominated by young Goodding's Willow Riparian habitat. Photo is facing south.

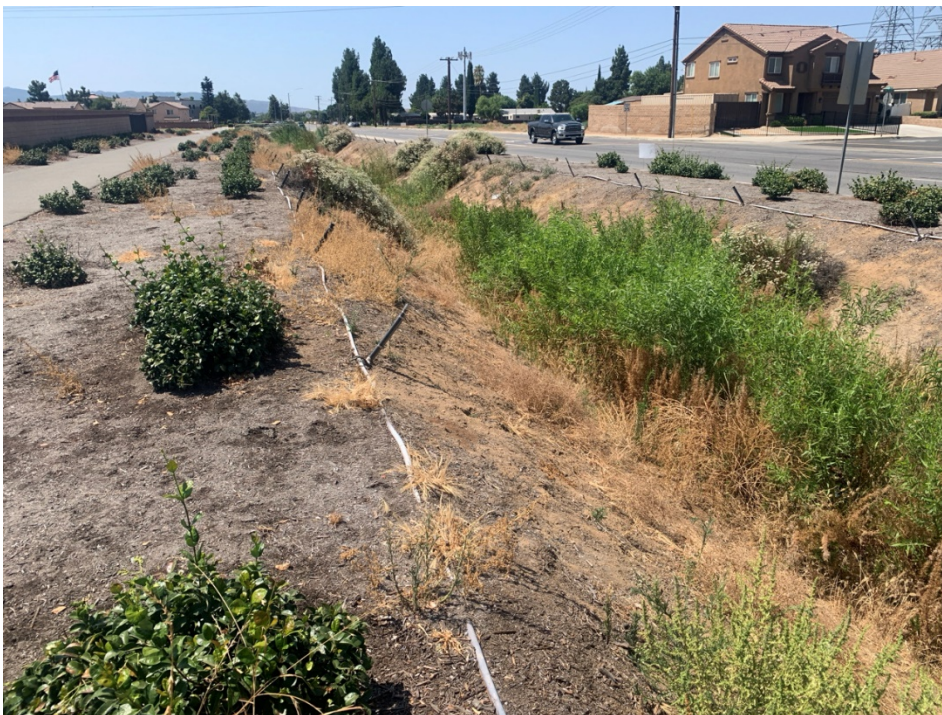
**Photo 2.**

Overview photo of Cherry Channel drainage from the middle of the Project site. Disturbed Goodding's Willow Riparian habitat begins to transition into cattail marsh habitat. Photo is facing south.

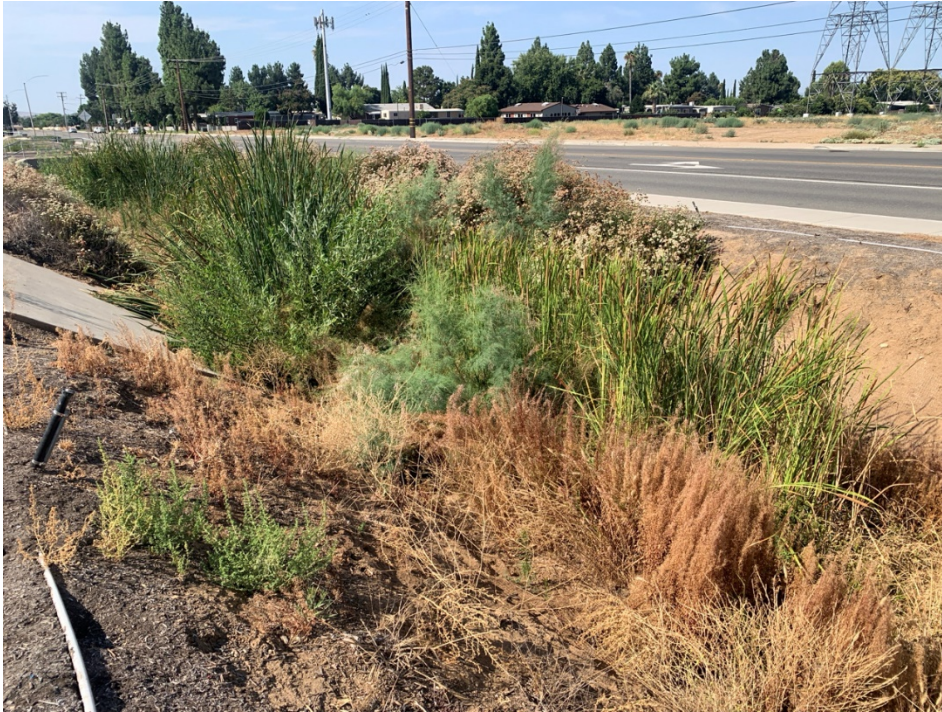
**Photo 3.**

Cattail marsh habitat with Ruderal vegetation lining the slopes located near the middle of the drainage. Photo is facing southwest.

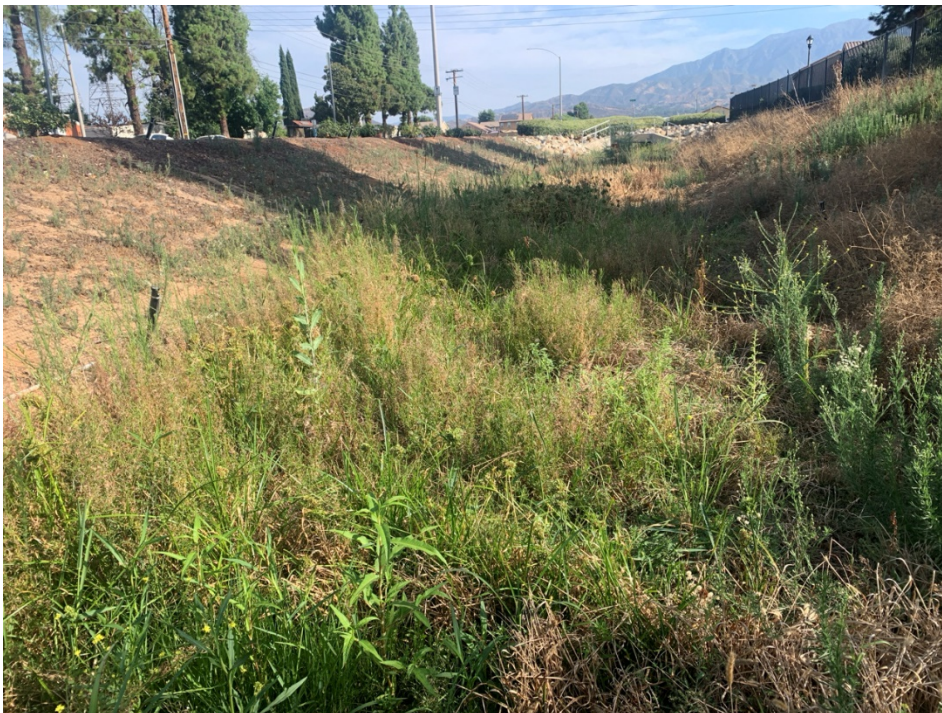
**Photo 4.**

Section on the southern half of the drainage that is dominated by Disturbed Wild Tarragon habitat. Slopes of the drainage are Ruderal with scattered natives including horseweed and California buckwheat. Photo is facing north.

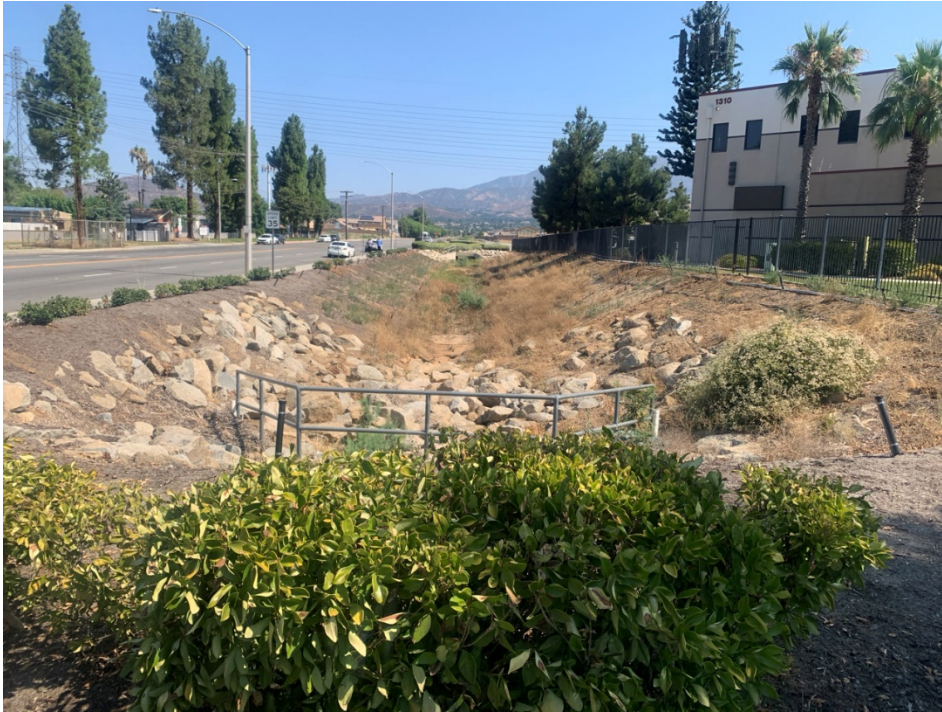
**Photo 5.**

Overview of the southern portion of the drainage. This area is dominated with Ruderal vegetation. Ornamental vegetation lines the outsides of the channel. Photo is facing north.

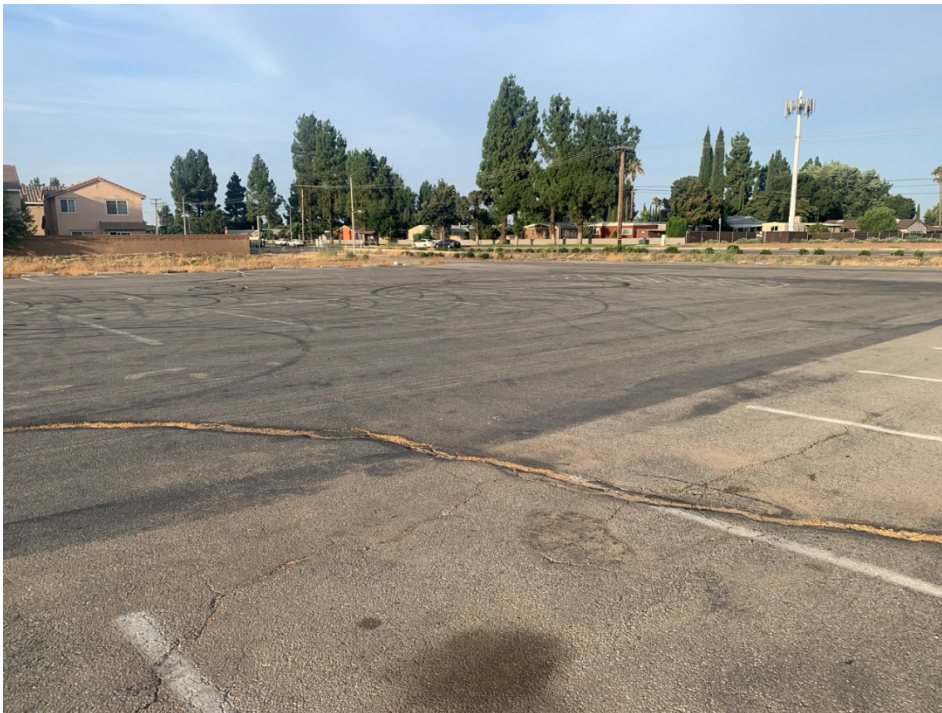
**Photo 6.**

Overview photo of the parking lot located east of the drainage. More Ruderal vegetation is located on both sides of the Parking lot. Photo is facing southwest.

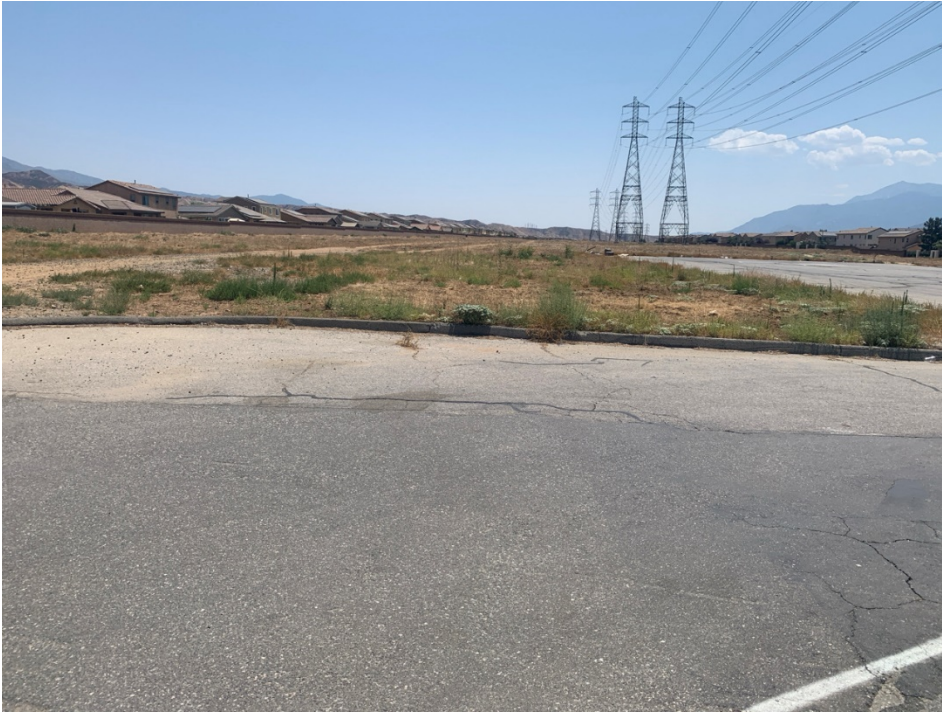
**Photo 7.**

Overview of the open space located along the SCE power lines. This area has a low potential for BUOW. Soils look freshly tilled/mowed. Photo is facing east.

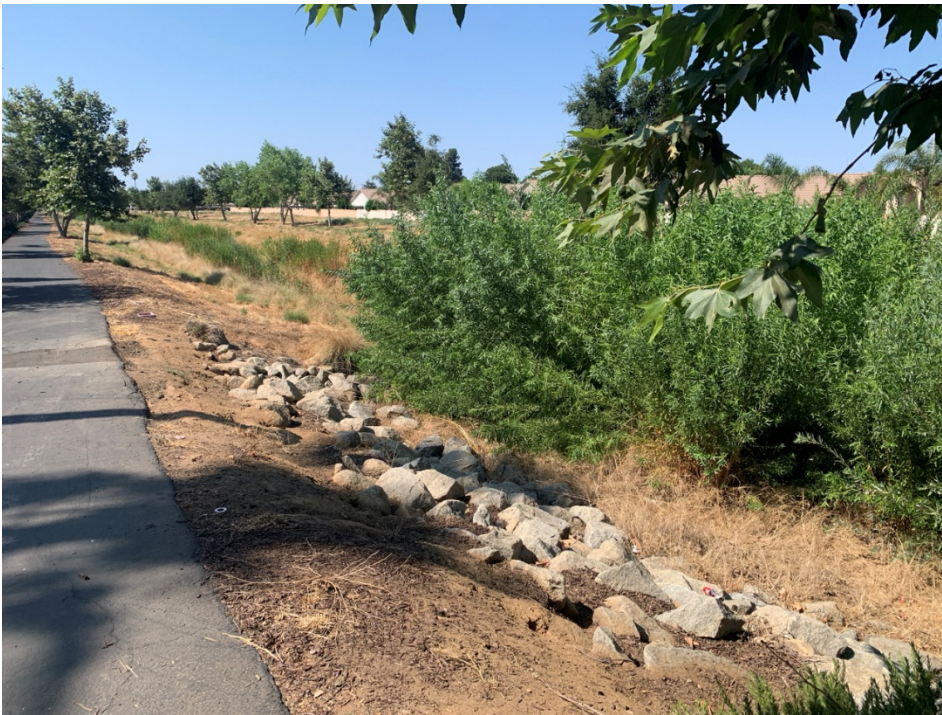
**Photo 8.**

Overview photo of the natural drainage (Potrero Creek) located south, outside of the Project site boundary. This drainage leads to San Jacinto River which is a NWI mapped waterway. Photo is facing southwest.

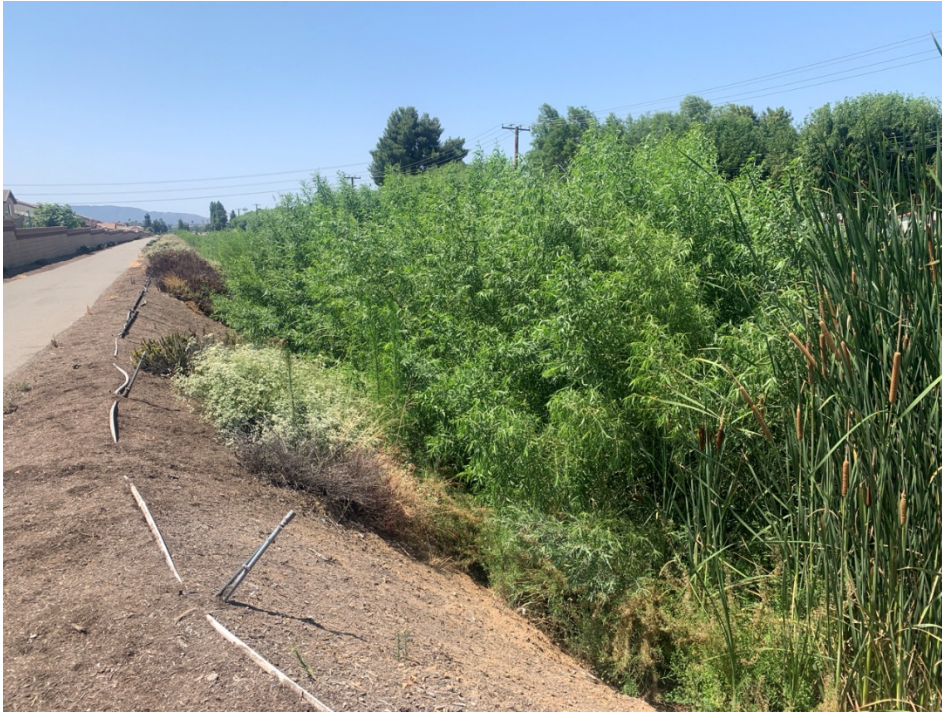
**Photo 1.**

Overview photo of Cherry Channel drainage from the north end. The northern half of the drainage is dominated by young Goodding's Willow Riparian habitat. Photo is facing south.

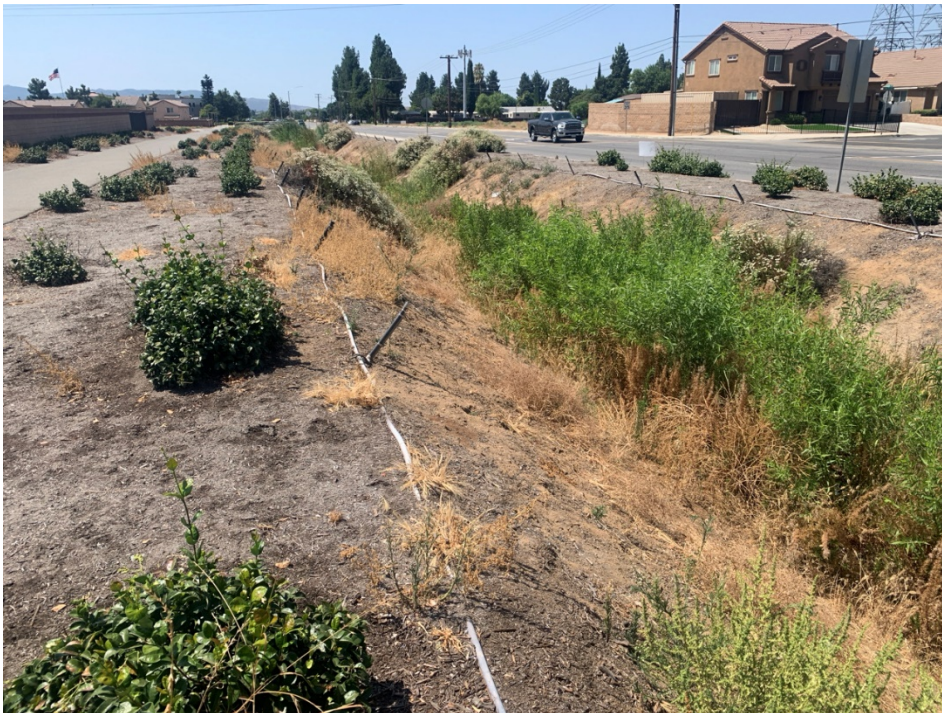
**Photo 2.**

Overview photo of Cherry Channel drainage from the middle of the Project site. Disturbed Goodding's Willow Riparian habitat begins to transition into cattail marsh habitat. Photo is facing south.

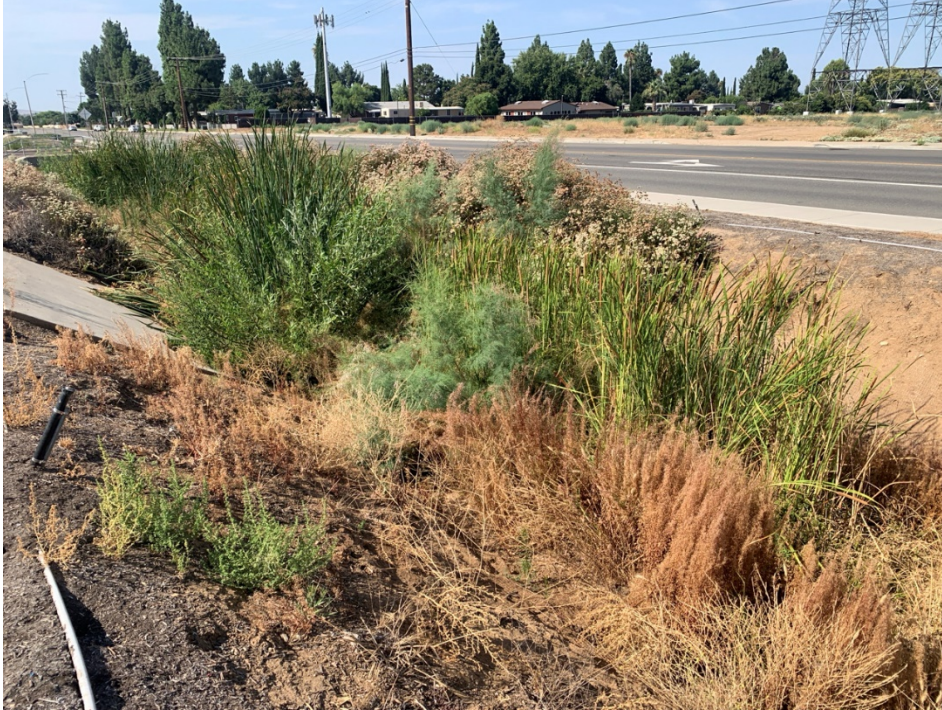
**Photo 3.**

Cattail marsh habitat with Ruderal vegetation lining the slopes located near the middle of the drainage. Photo is facing southwest.

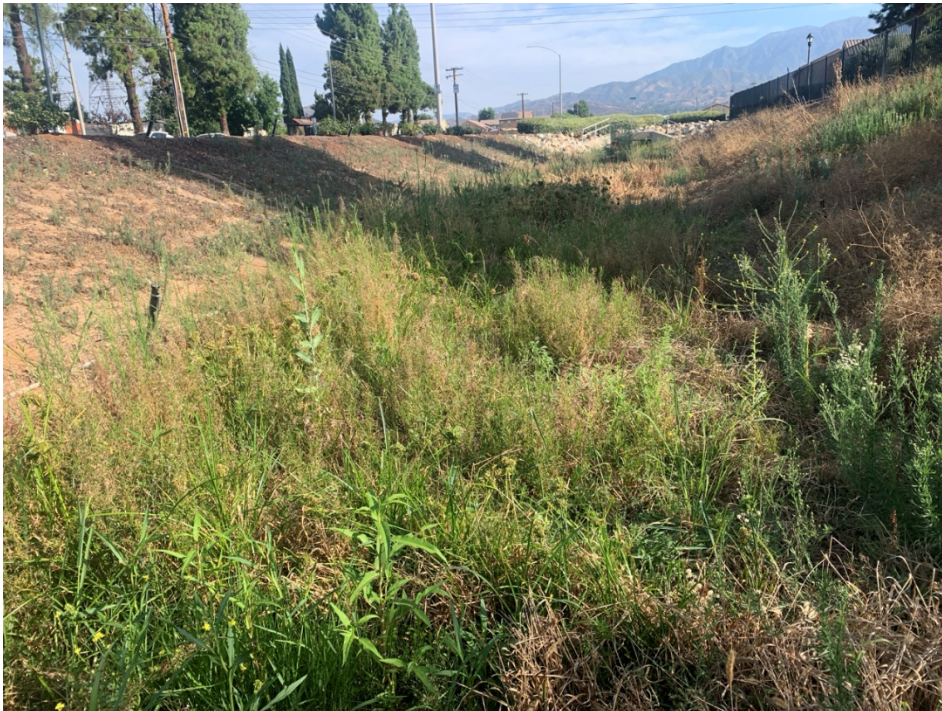
**Photo 4.**

Section on the southern half of the drainage that is dominated by Disturbed Wild Tarragon habitat. Slopes of the drainage are Ruderal with scattered natives including horseweed and California buckwheat. Photo is facing north.

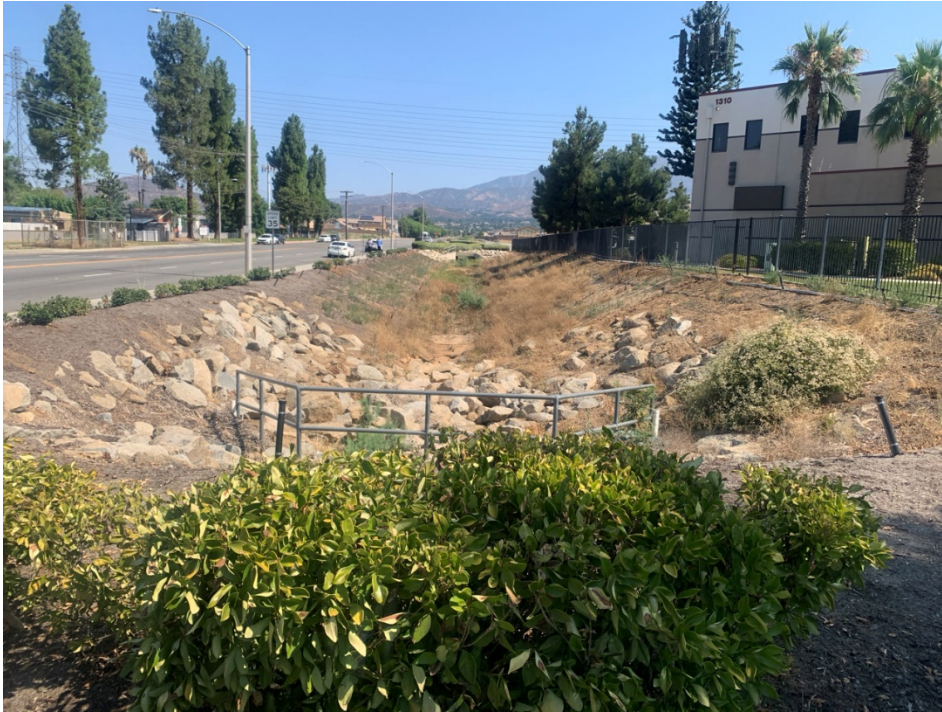
**Photo 5.**

Overview of the southern portion of the drainage. This area is dominated with Ruderal vegetation. Ornamental vegetation lines the outsides of the channel. Photo is facing north.

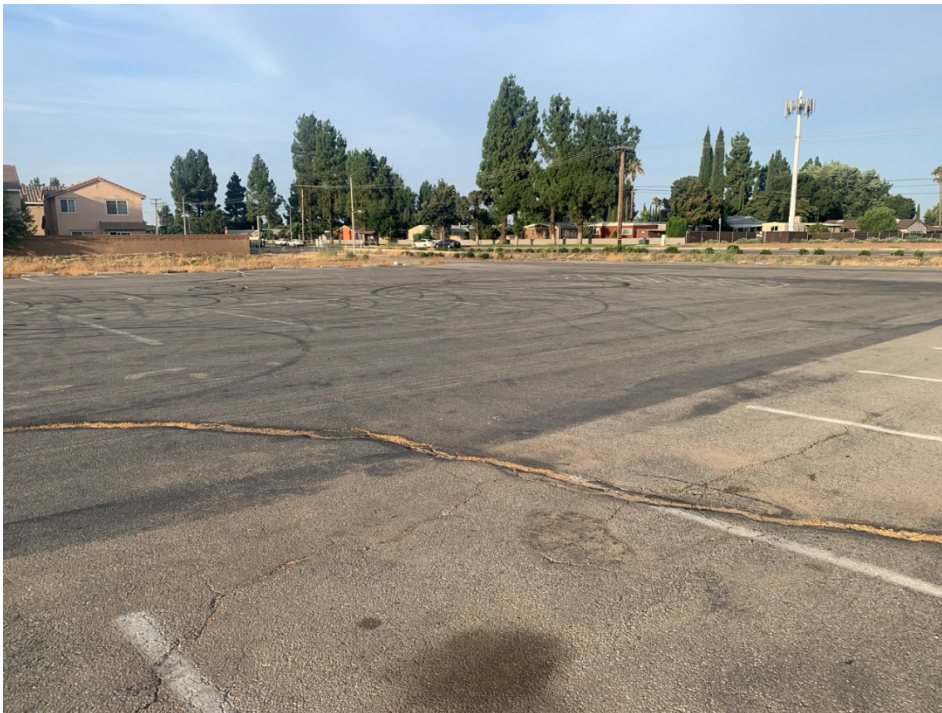
**Photo 6.**

Overview photo of the parking lot located east of the drainage. More Ruderal vegetation is located on both sides of the Parking lot. Photo is facing southwest.

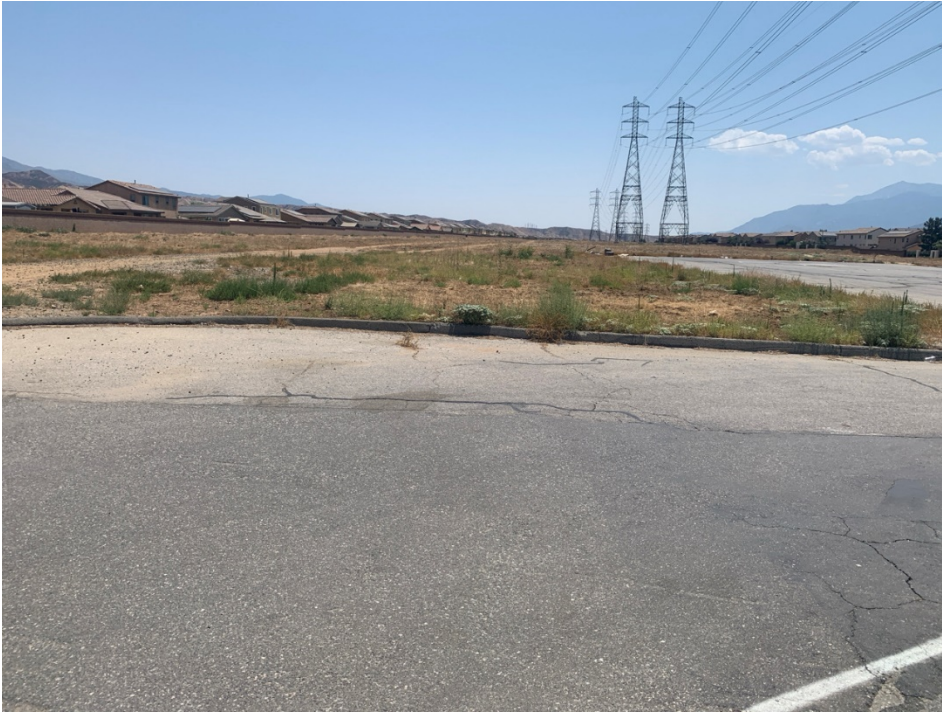
**Photo 7.**

Overview of the open space located along the SCE power lines. This area has a low potential for BUOW. Soils look freshly tilled/mowed. Photo is facing east.

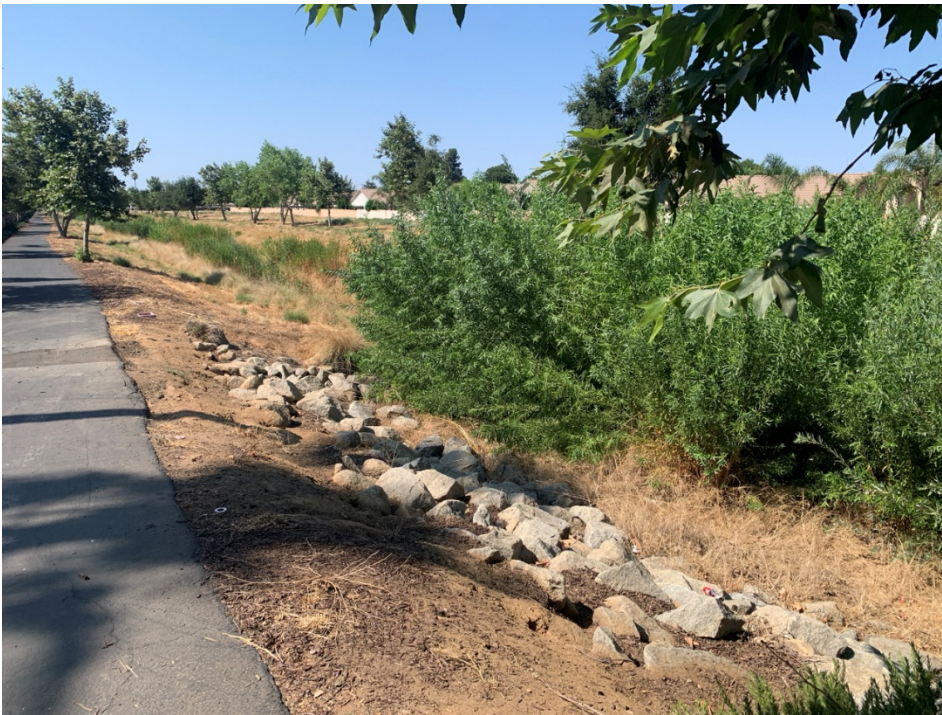
**Photo 8.**

Overview photo of the natural drainage (Potrero Creek) located south, outside of the Project site boundary. This drainage leads to San Jacinto River which is a NWI mapped waterway. Photo is facing southwest.
